A study of the Browning M2 Quick Change Barrel and problems experienced in the Norwegian Armed Forces

Svein Morten Bergsrud
Pål Martin Greni

FFI report

21/00127

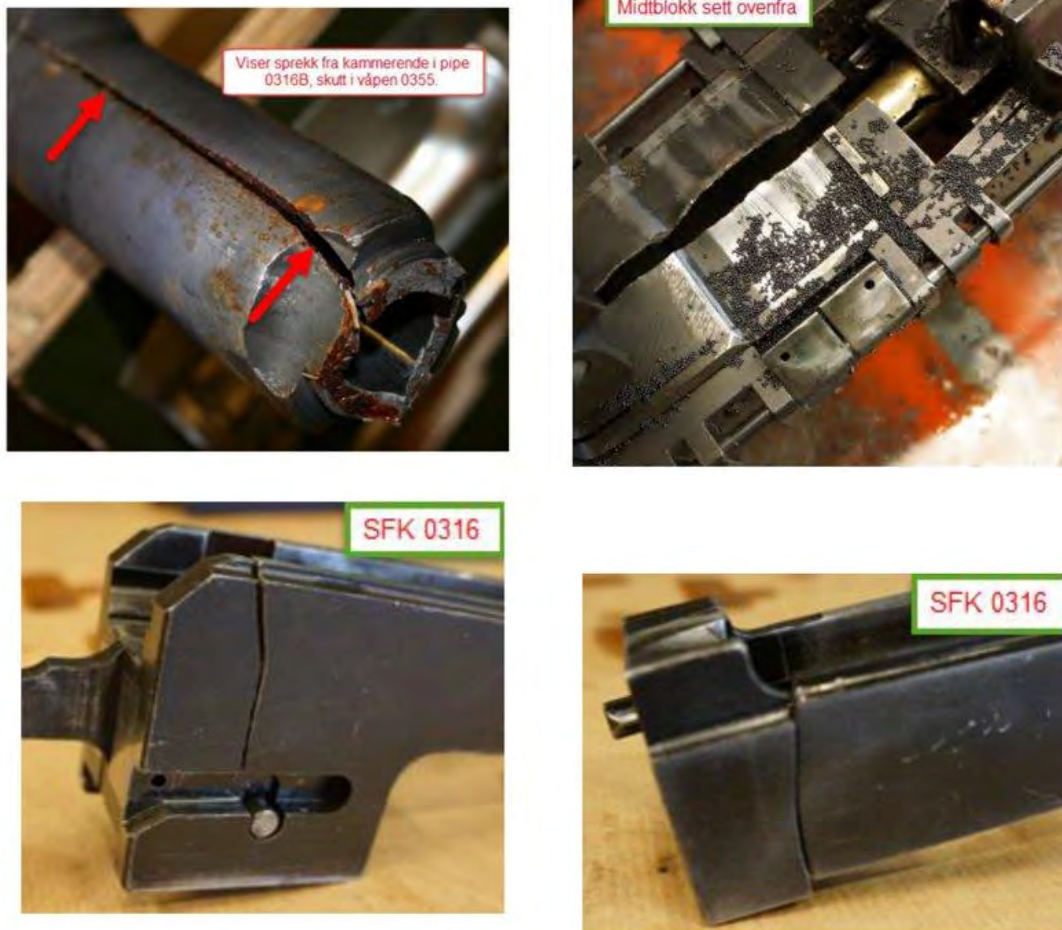
In 2014 a severe weapon explosion occurred with ordinary Target Practise (TP) ammunition called NM241 (Ball) and NM242 (Tracer). The barrel was teared open and the barrel extension cracked, Figure 1.1. A Technical Investigation Group (TUG) was established to investigate the failure. During their work more weapon failures were discovered. It became obvious that a lot of weapons had cracks in both barrel and barrel extension. The cracks in the barrel were found in the threaded segments at the back end, and the barrel extension showed cracks in the left front part and right back part.

Figure 1.1 Pictures of the weapon with the cracked barrel and barrel extension.

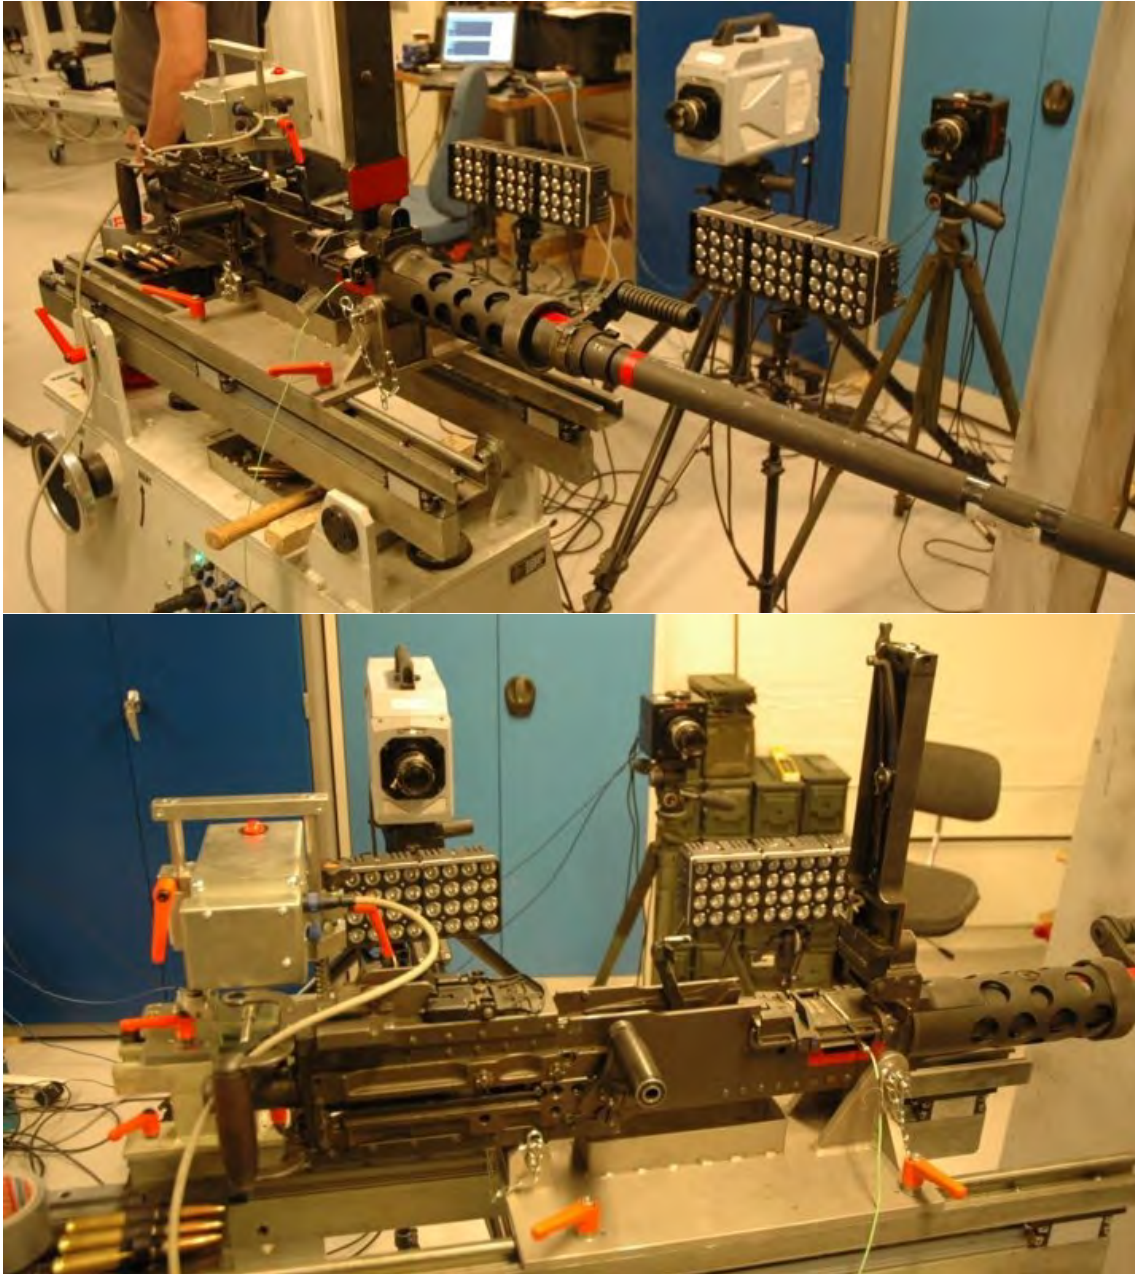
Figure 2.5 Test setup with high speed cameras and pressure measurements.

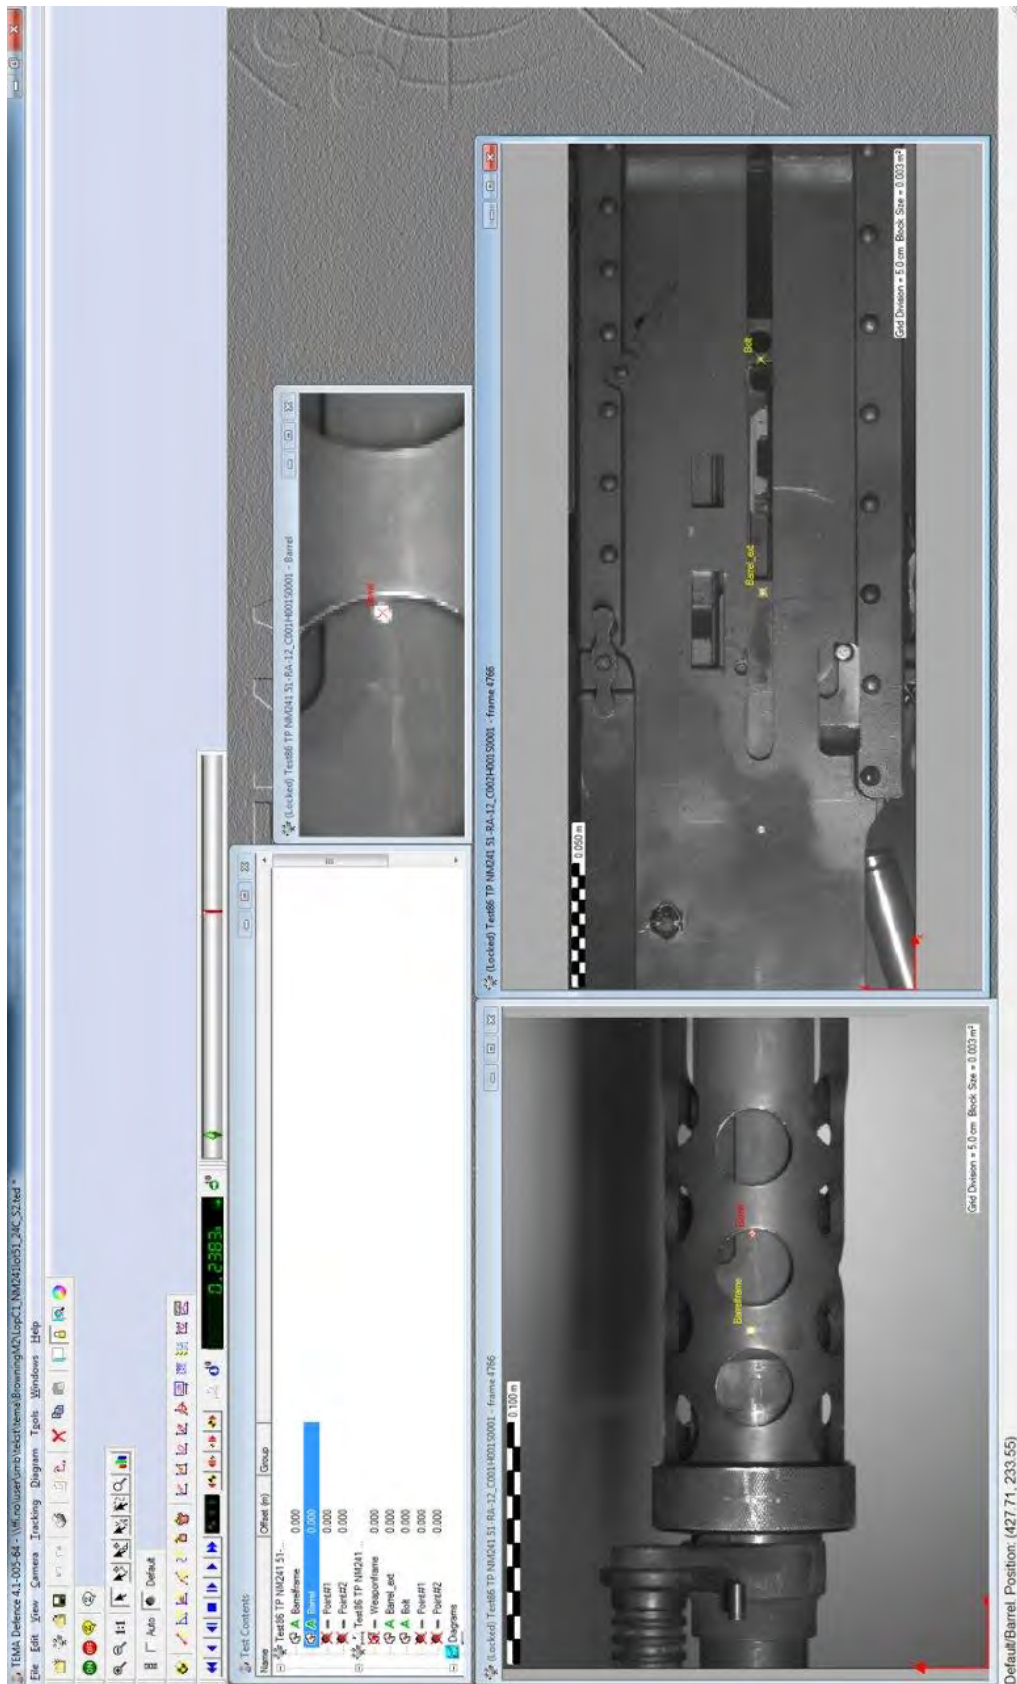
In Figure 2.6 the layout from TEMA Defence is shown. The FASTCAM AX-200 was used to film the barrel and the weapon frame, the FASTCAM SA-Z was used to film the barrel extension and the bolt. All the parts were marked with a small dot of white paint to be the marker for the software. The best tracking algorithm for this analysis were found to be the "Center of gravity". This algorithm tracks the center of gravity of the contour of a marker. The white dots made a perfect contrast and the software had no issues with tracking the points from frame to frame.

Figure 2.6 Motion Analysis software TEMA Defense.

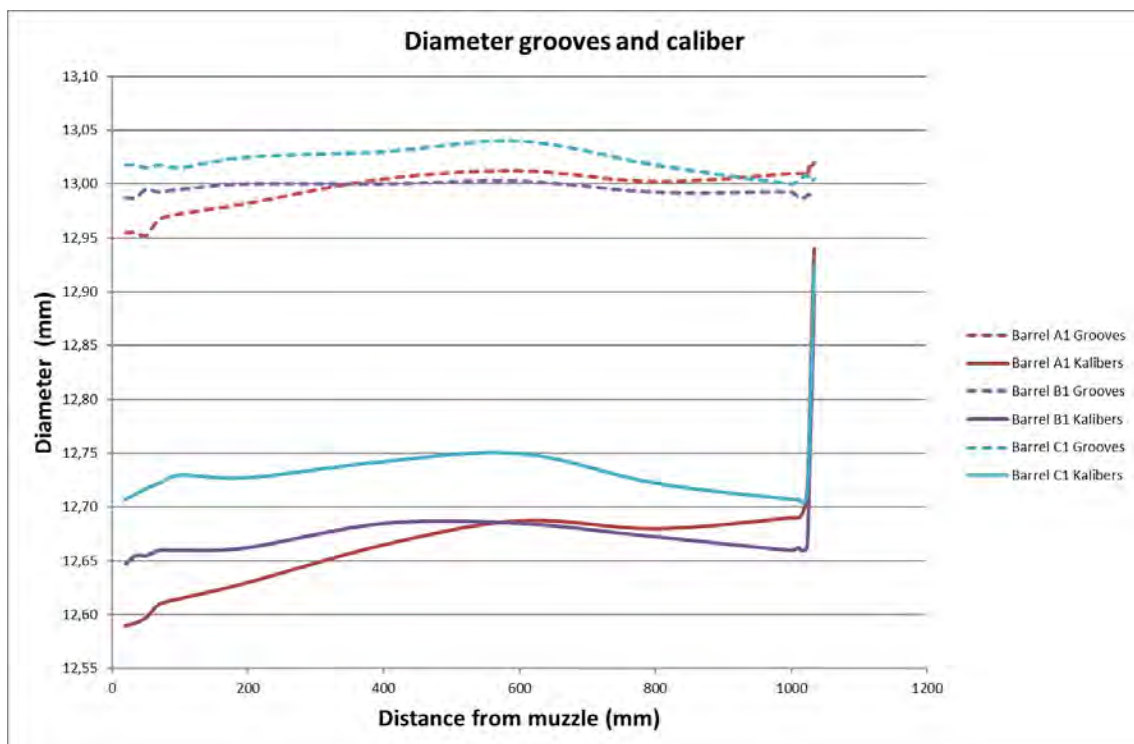
To get a better measurement of the inner diameter of the barrels, a Robinca gun barrel measurement was performed at Romerike tekniske verksted (RTV). This system measures both the groove diameter and the caliber diameter. The barrels have eight grooves and lands. There are therefore four measurements for the caliber and the grooves diameter at each position in the barrel. Measurements were taken at 17 positions from the muzzle back to the commencement of rifling. Measurement reports from RTV can be found in Appendix B.

Barrel B1 shows a slightly higher maximum pressure than barrel A1 and C1. This could be due to the barrel being tighter in the area from the chamber and about half way down the barrel, because this is the area where the pressure builds up and reaches its maximum value, but measurements from more barrels would be necessary to conclude on this.

Figure 3.7 Diameter of grooves and caliber measured with Robinca gun barrel measurement system.

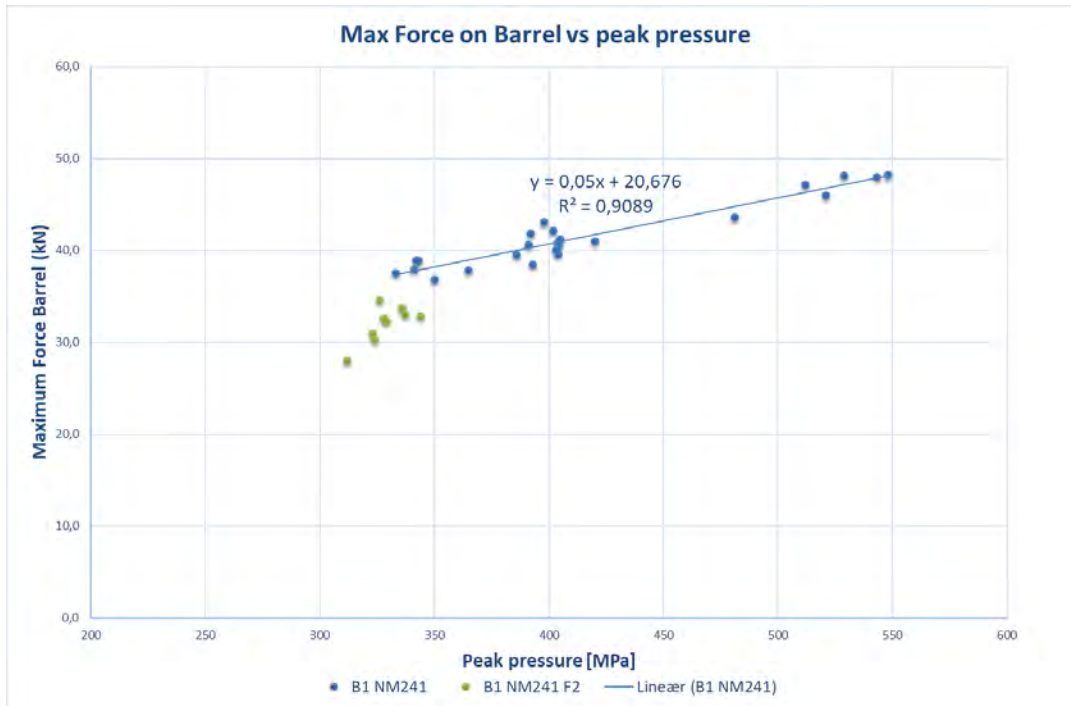
Figure 4.15 Maximum force on barrel vs peak pressure. Barrel B1 with NM241 and NM241F2 with temperature stable powder.

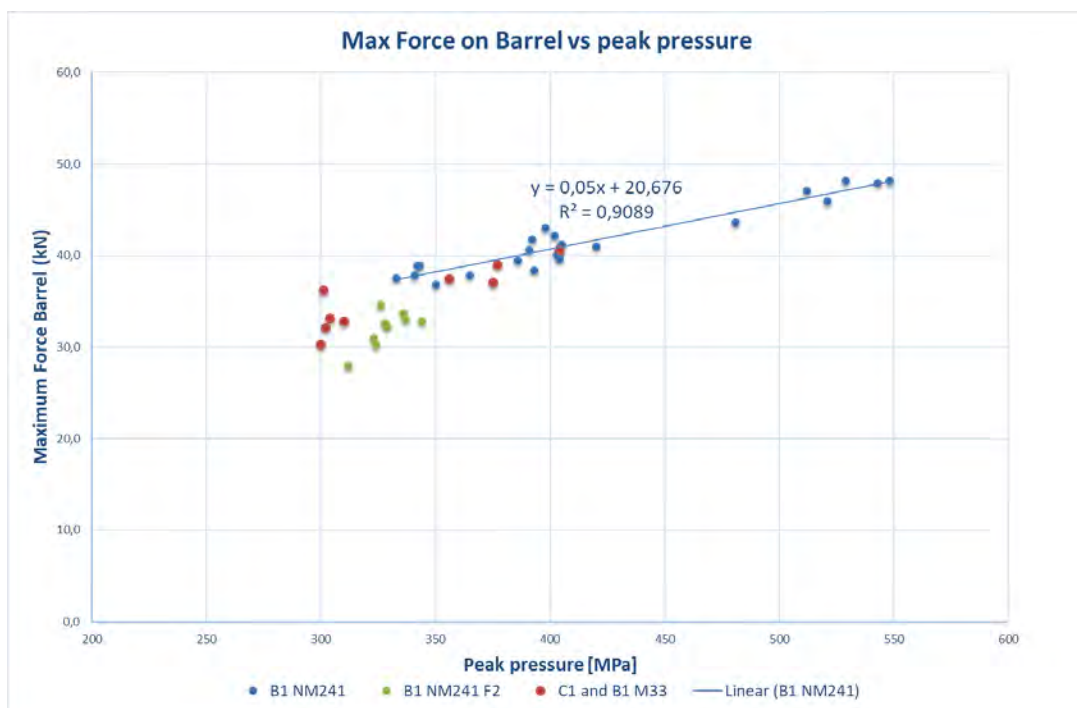
Because the M33 also have ball powder (unknown type and manufacturer), some shots were analysed with the M33. The analysed shots were fired with barrel B1 and C1 and powder temperatures of 21 and 63 °C. In figure 4.17, the maximum barrel force as a function of peak pressure for M33 is shown together with the values for the NM241 and NM241F2. We see that the peak pressure and barrel force for the M33 shots have a correlation comparable to the NM241. This strengthens the theory that the extruded powder is the cause of the observed lower barrel force as a function of pressure.

Figure 4.17 Maximun force on barrel vs peak pressure. Barrel B1 with NM241, NM241F2 and M33(also barrel C1).

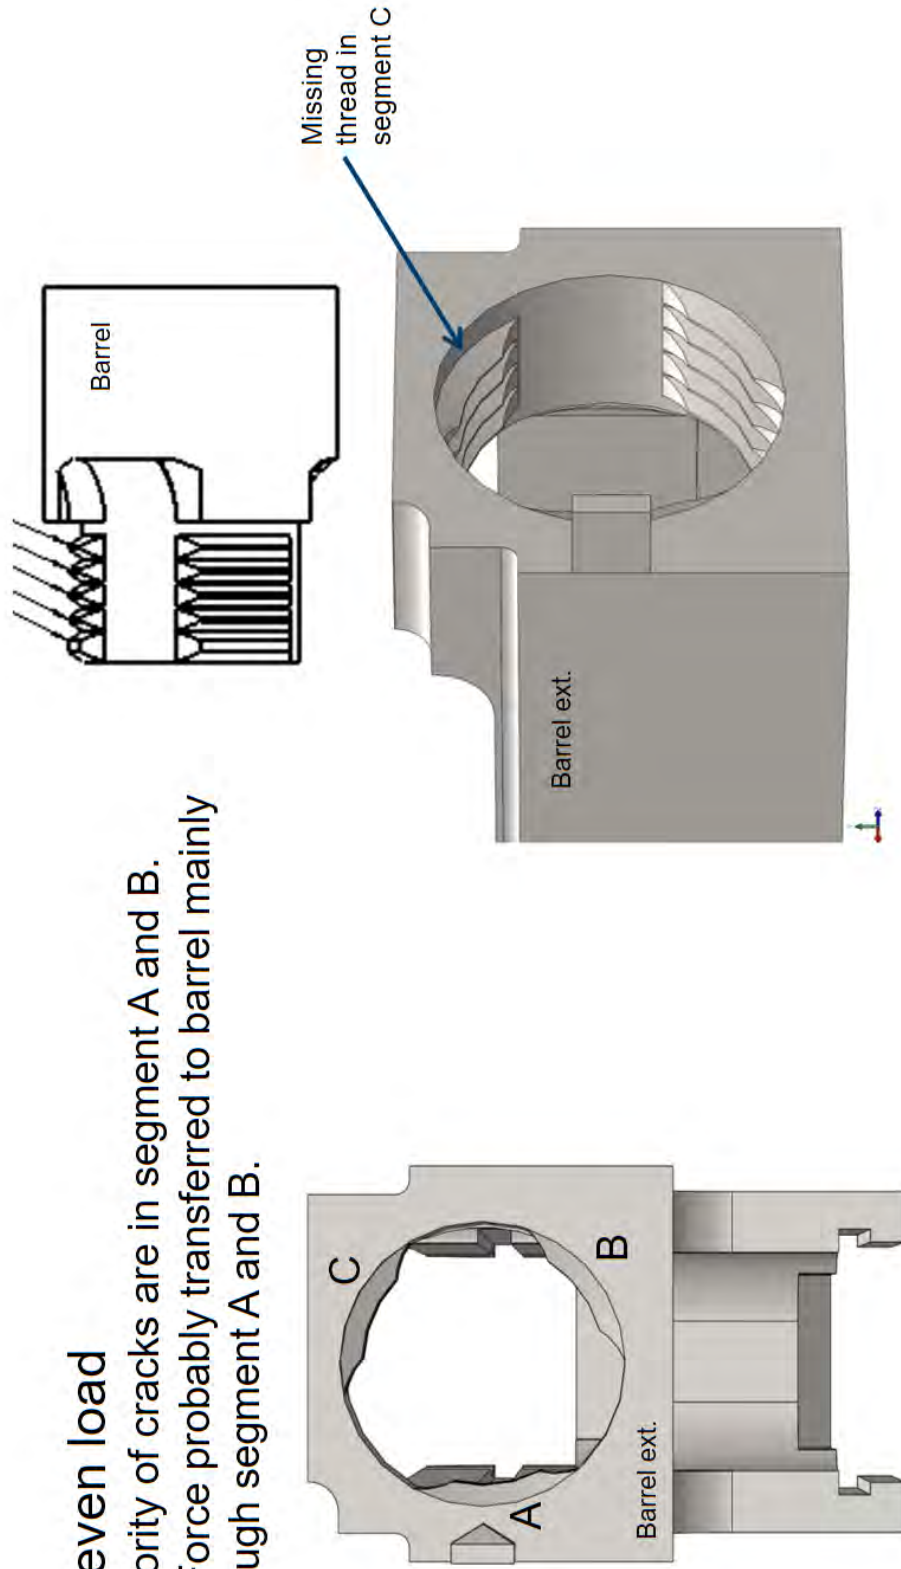
As can be seen in Table 5.1 to 5.6 segment A and B have cracks in most of the ridges from 1 to 4. Segment C has significantly fewer cracks. Ridge 1 in segment A and B always has the deepest crack within the segment, whereas segment C never has cracks in ridge 1. The reason for missing cracks in ridge 1 of segment C is a missing ridge/thread in the segment on the barrel extension. This is shown in Figure 5.4. This undoubtedly leads to a significant increased load on segment A and B during firing, especially in ridge 1 which most likely get most of the load during firing. This will undoubtedly also cause an highly uneven/non concentric load on the barrel extension, explaining the previously described cracks in the barrel extension.

Figure 5.4 Missing I. ridge in segment C of the barrel extension.

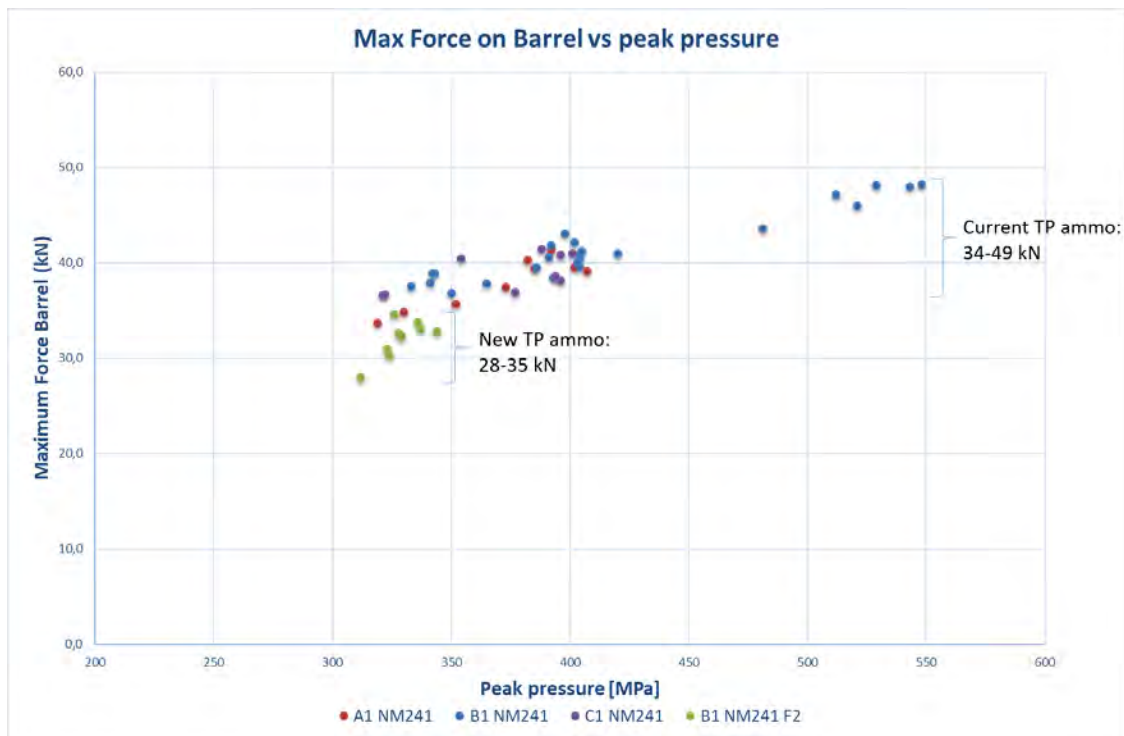
Figure 6.1 Maximum force on barrel vs peak pressure. Barrel A1, B1 and C1 with NM241 and B1 with NM241F2

The easiest way to reduce the forces acting on the barrel and barrel extension on all QCB-weapons in use to day, is to use ammunition with temperature insensitive powder, like the NM241F2. A second possible way could be to slightly adjust the geometry of the threads on the barrel and/or barrel extension, so that the forces could be taken up more evenly over all three segments and distributed over all threads within a segment. With regards to new weapons, a reduced backlash/smaller tolerances in combination with design (ref. Figure 5.4), material and surface finish improvements in the threaded areas, should greatly reduce the

risk of weapon failure due to fatigue in the barrel and barrel extension.

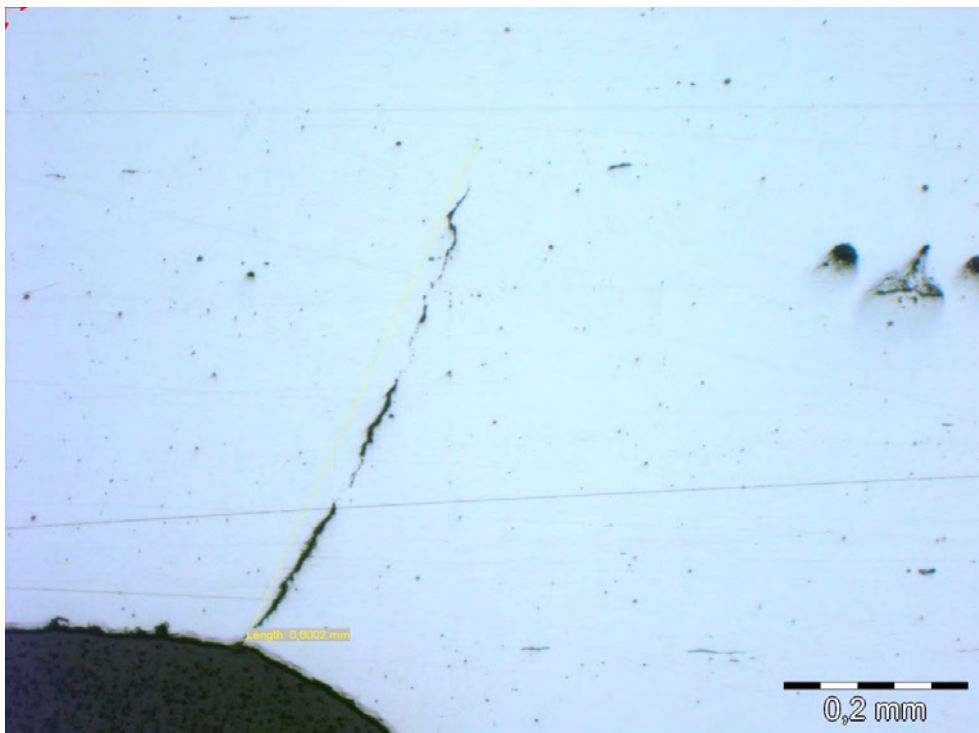
Figure C.3 Crack at segment B, first ridge on barrel no. 1393 (second cut)

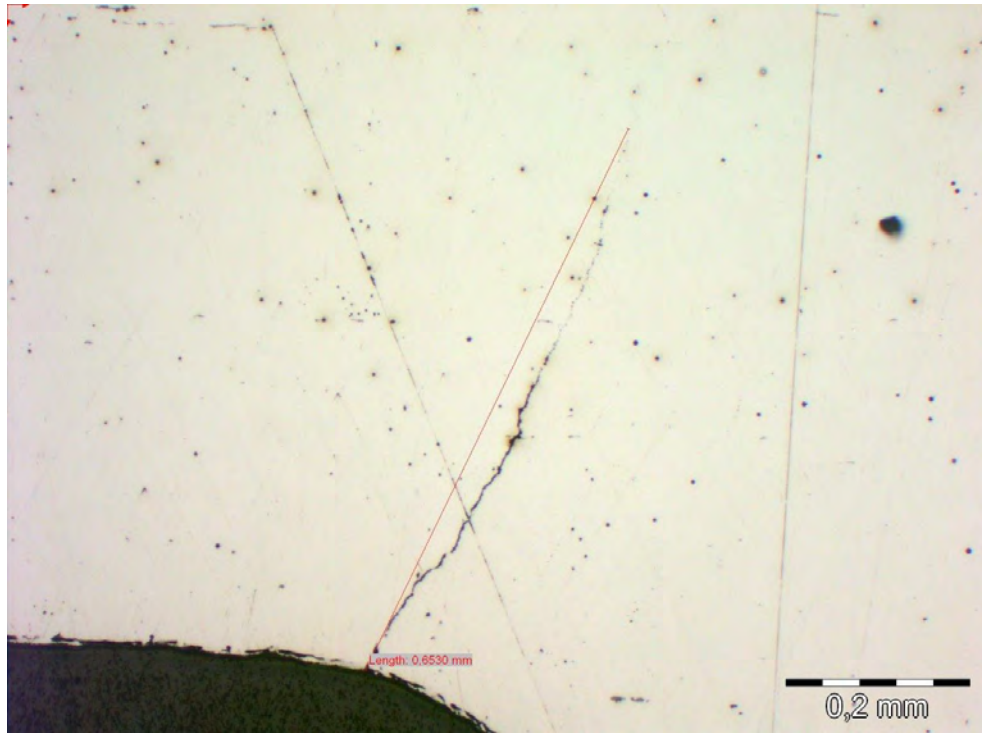
Figure C.4 Crack at segment B, first ridge on barrel no. 1393 (first cut)

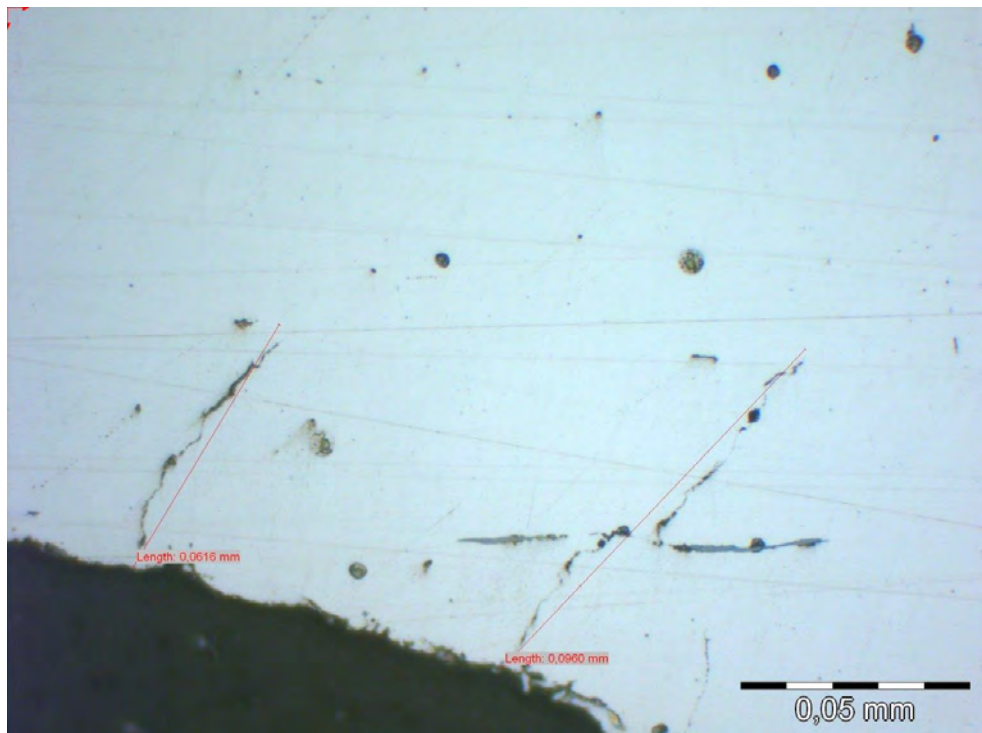
Figure C.5 Crack at segment B, second ridge on barrel no. 1393 (second cut)

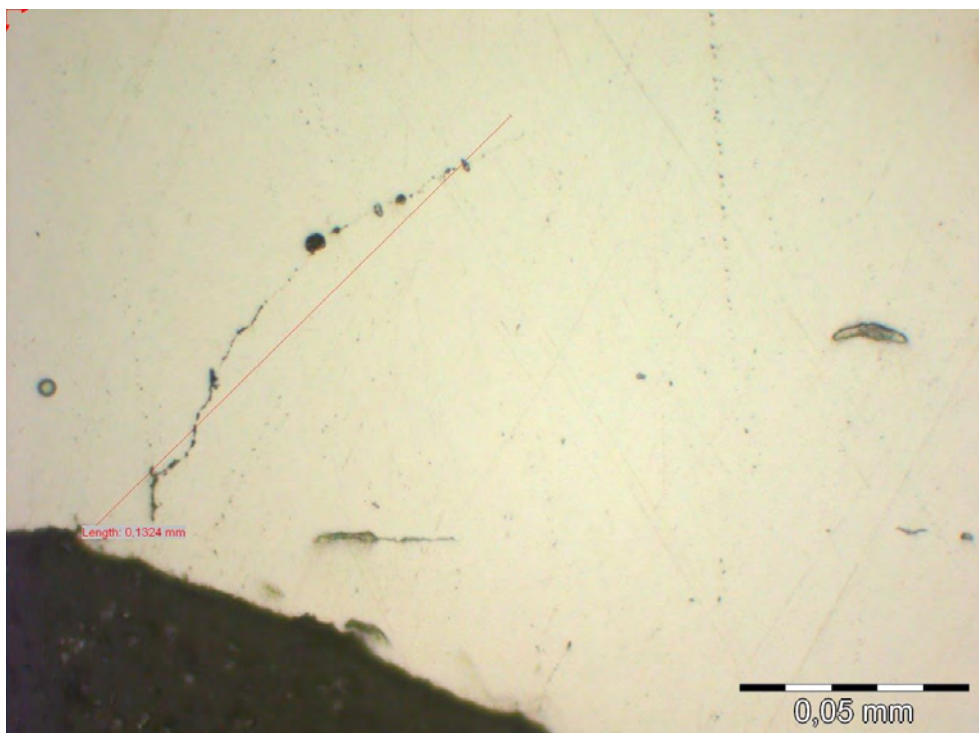
Figure C.6 Crack at segment B, second ridge on barrel no. 1393 (first cut)

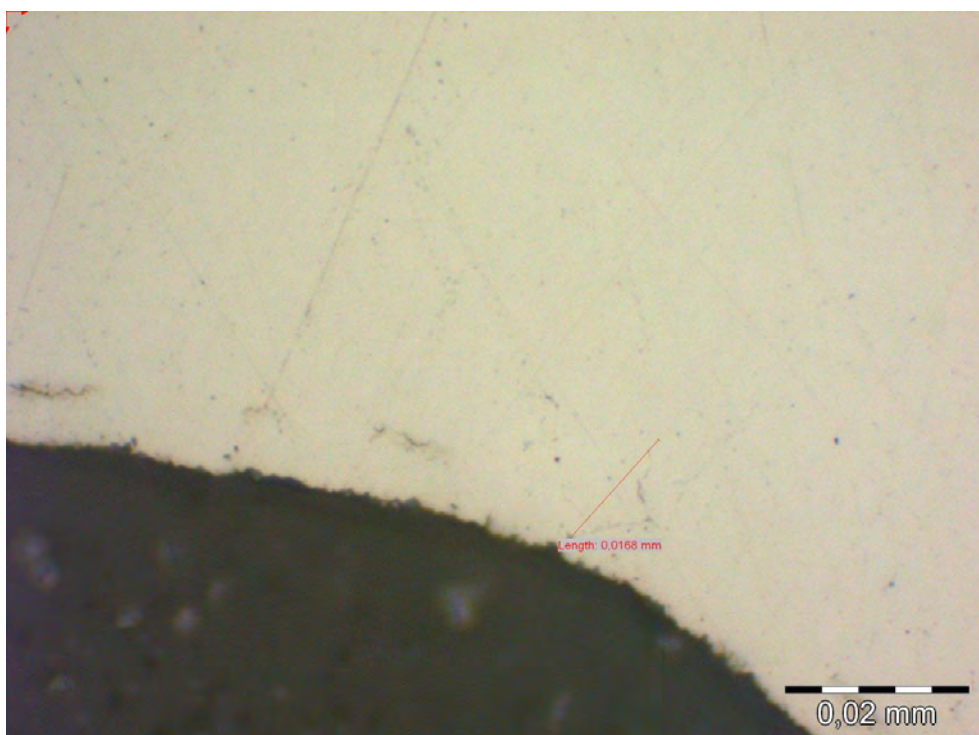
Figure C.7 Crack at segment B, fourth ridge on barrel no. 1393

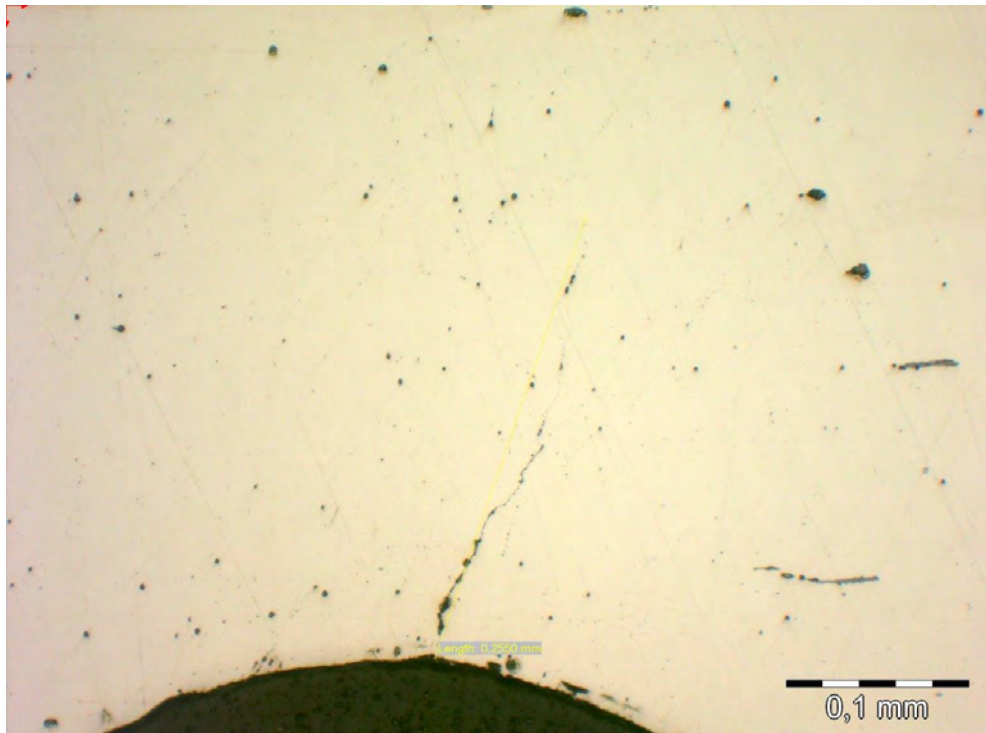
Figure C.8 Crack at segment C, second ridge on barrel no. 1393

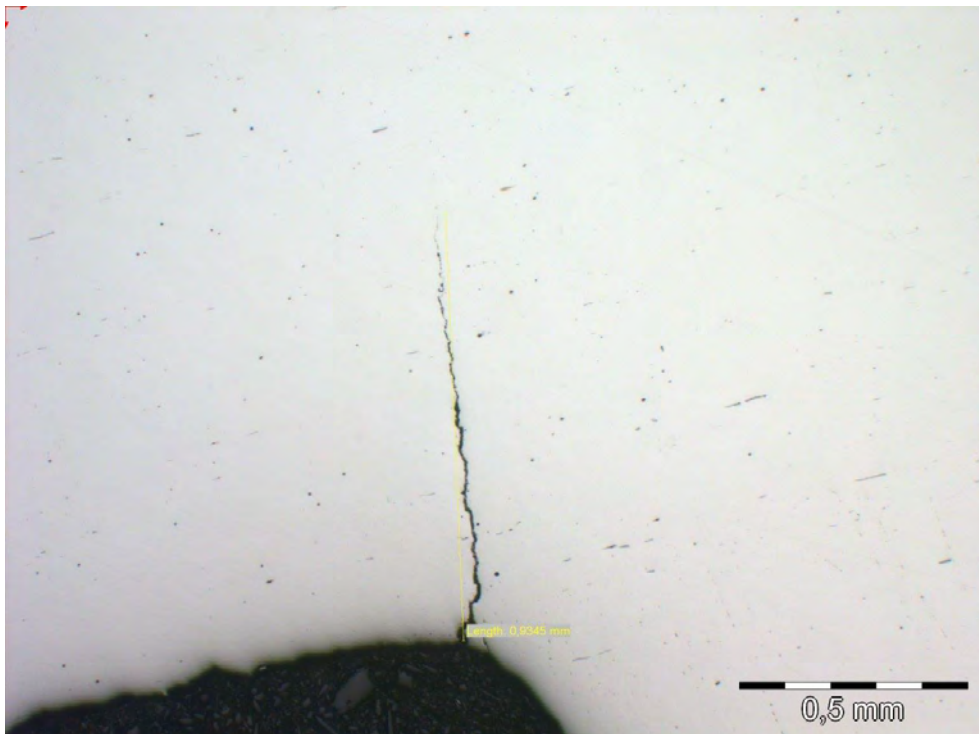
Figure C.9 Crack at segment C, second ridge on barrel no. 1613

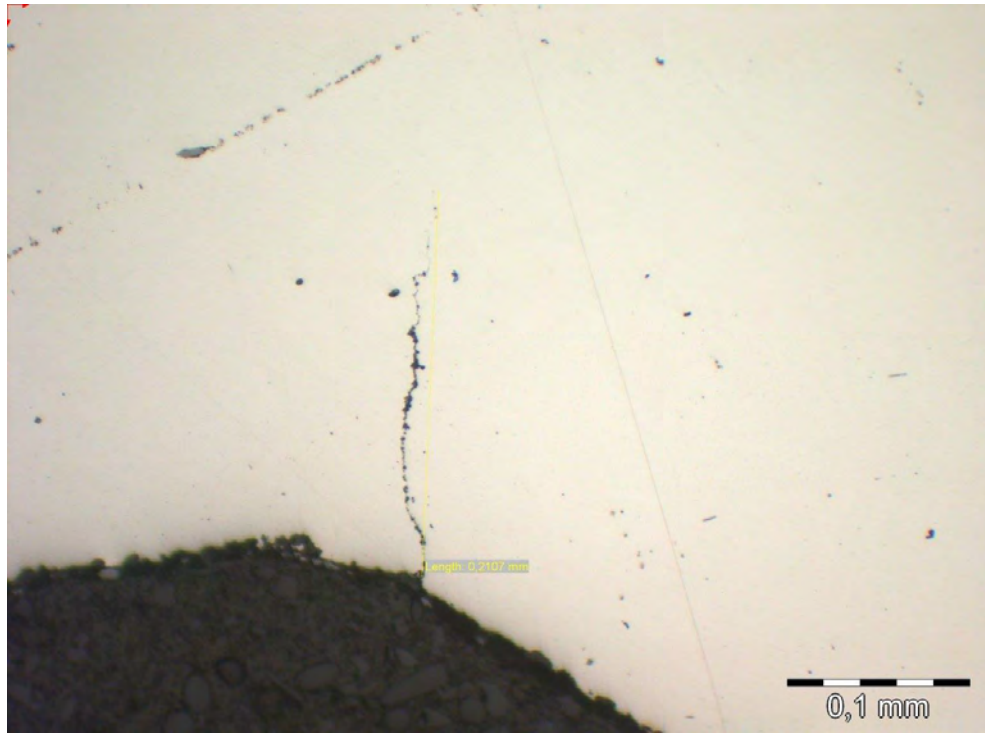
Figure C.10 Crack at segment C, second ridge on barrel no. 1613

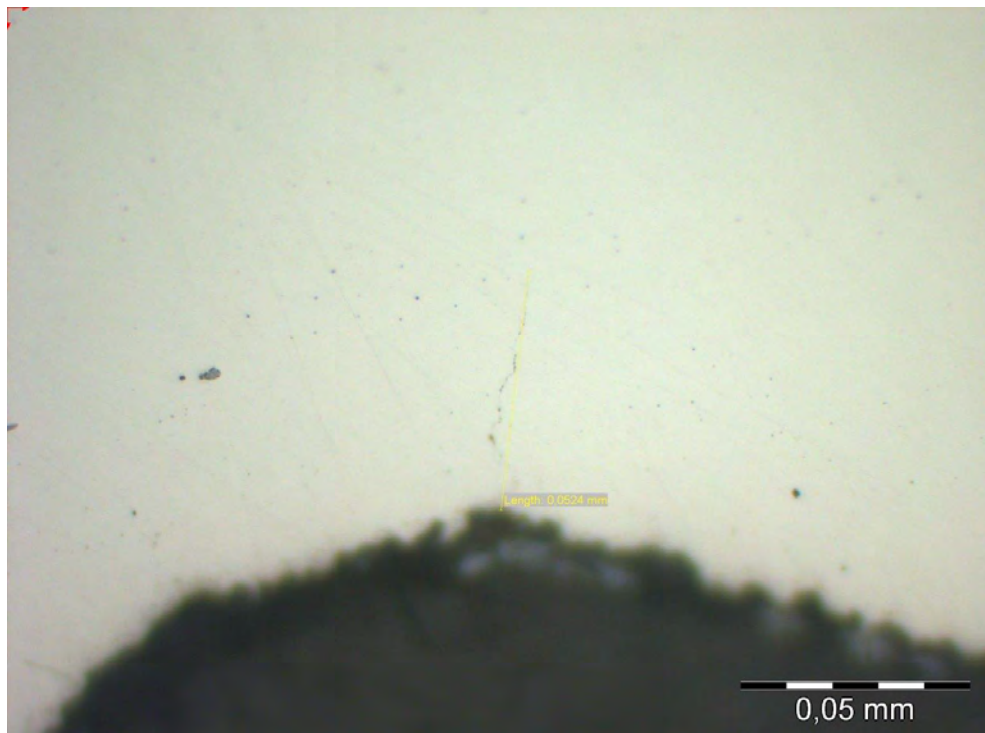
Figure C.11 Crack at segment C, second ridge on barrel no. 1613

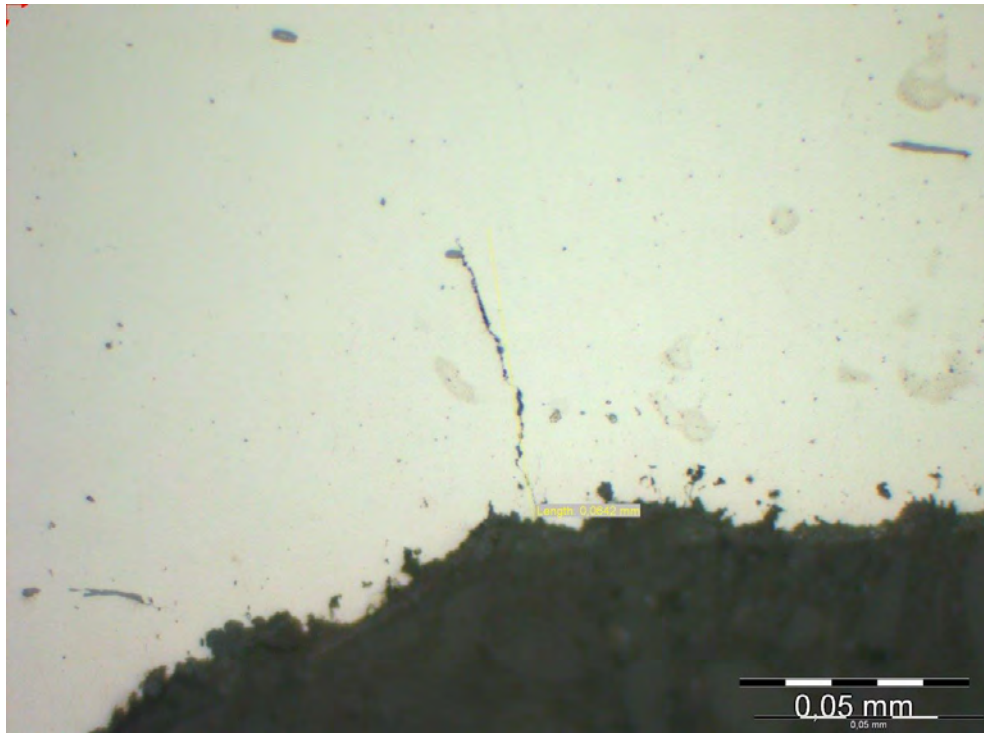
Figure C.14 Crack at segment C, second ridge on barrel no. 1613

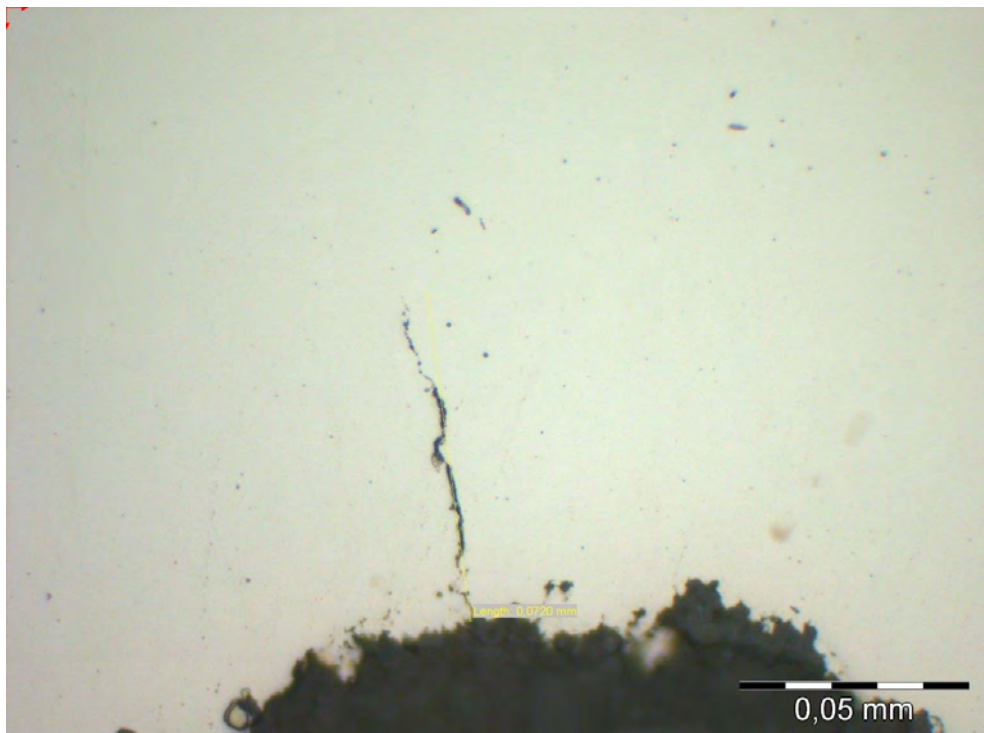
Figure C.15 Crack at segment C, second ridge on barrel no. 1613

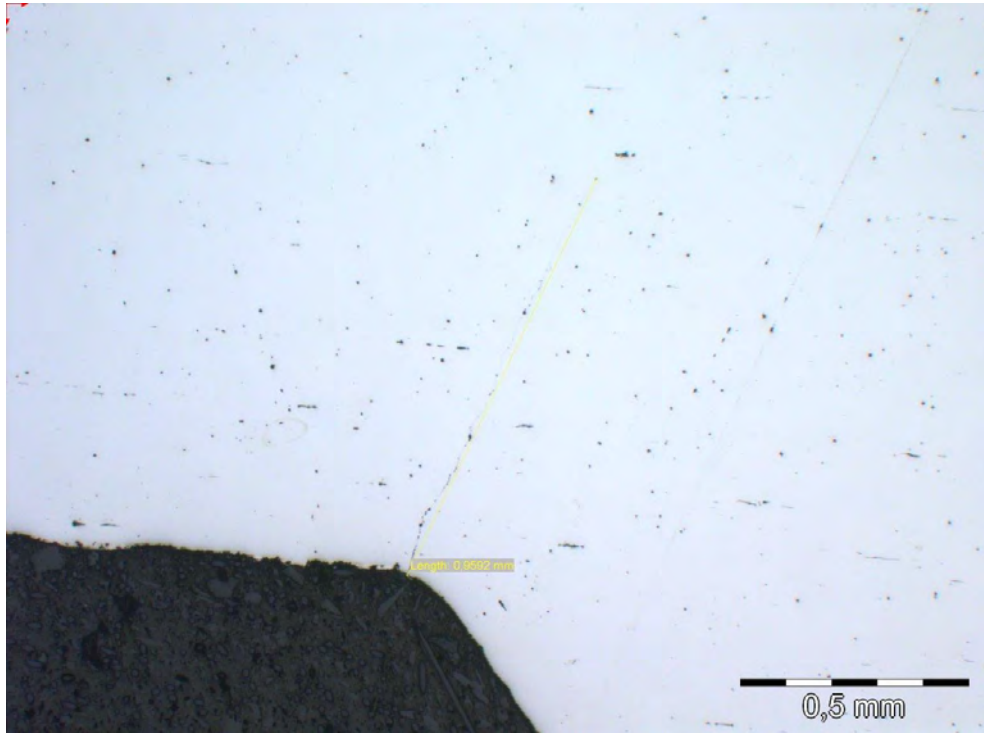
Figure C.18 Crack at segment A, first ridge on barrel no. 8832/6713

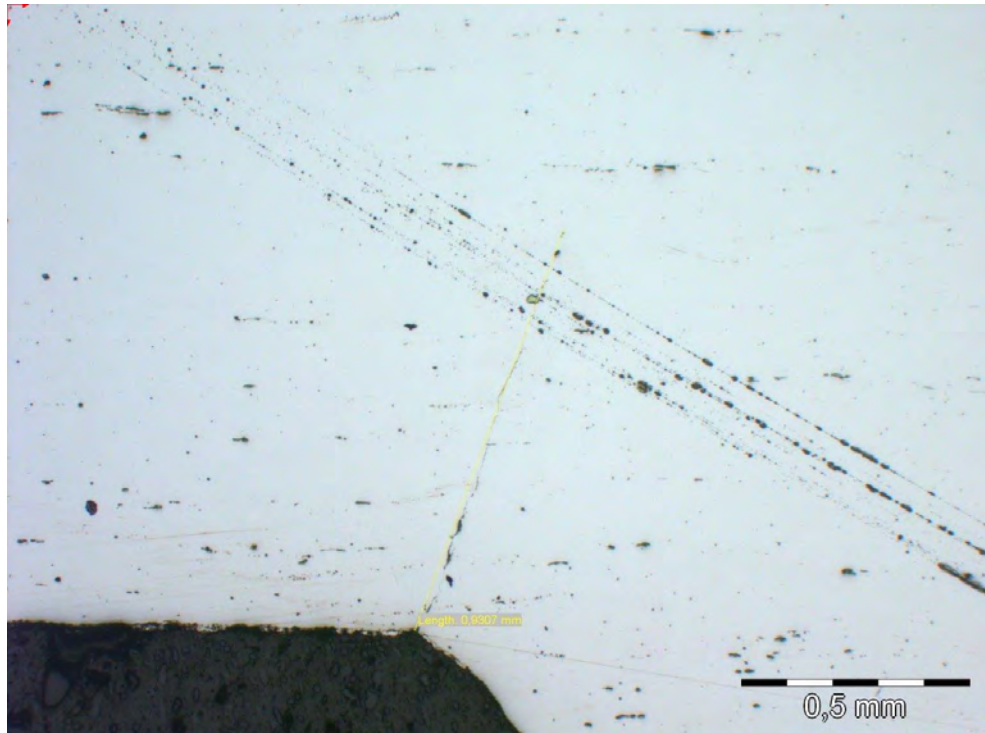
Figure C.21 Crack at segment B, first ridge on barrel no. 8832/6713

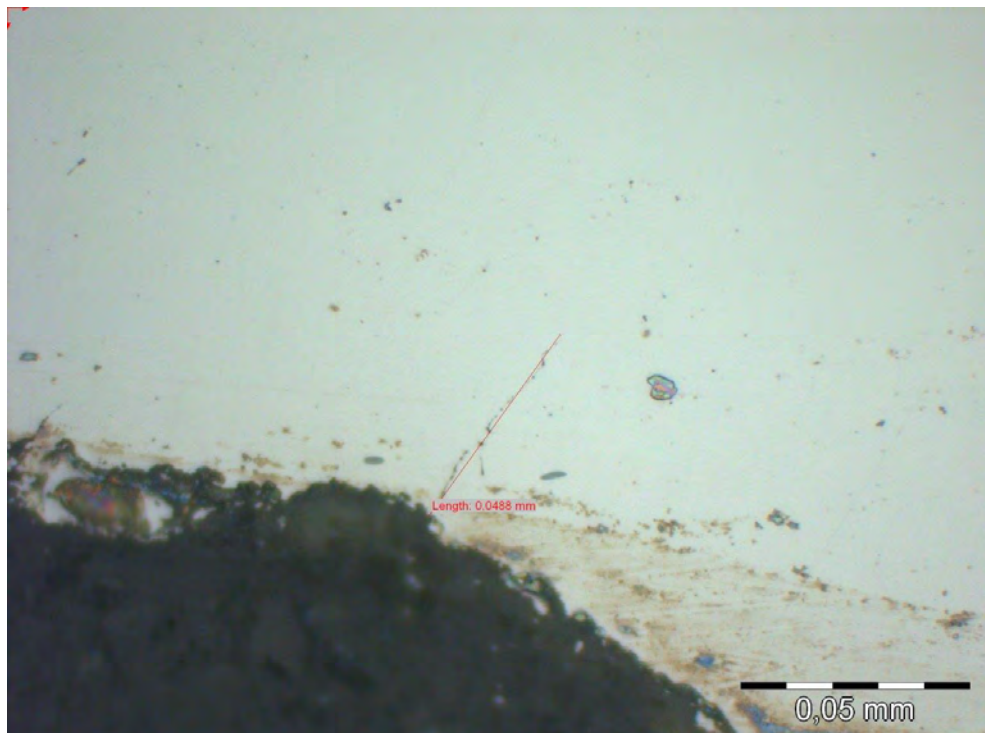
Figure C.22 Crack at segment B, second ridge on barrel no. 8832/6713

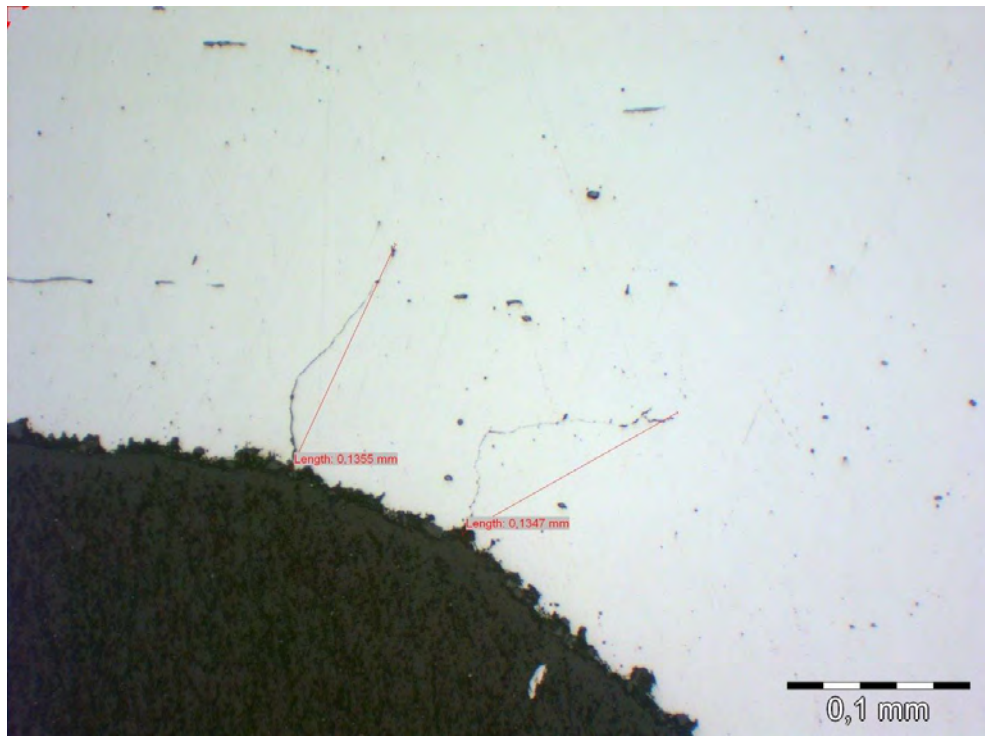
Figure C.25 Cut one in crack at segment A, first ridge on barrel no. 14389

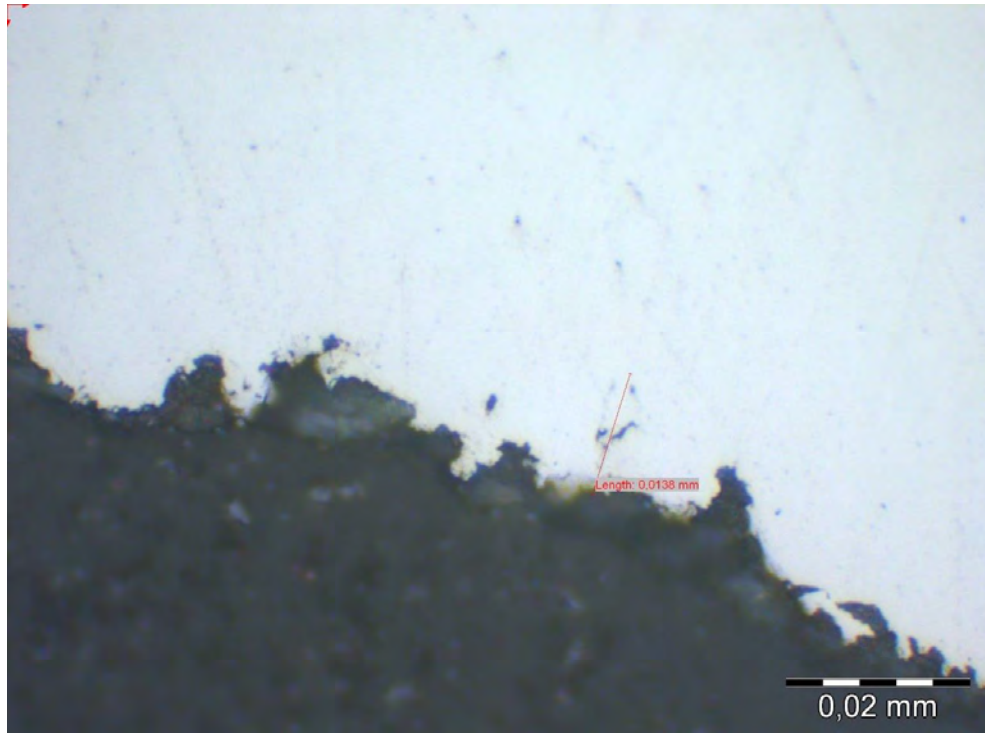
Figure C.28 Cut one in crack at segment A, fourth ridge on barrel no. 14389

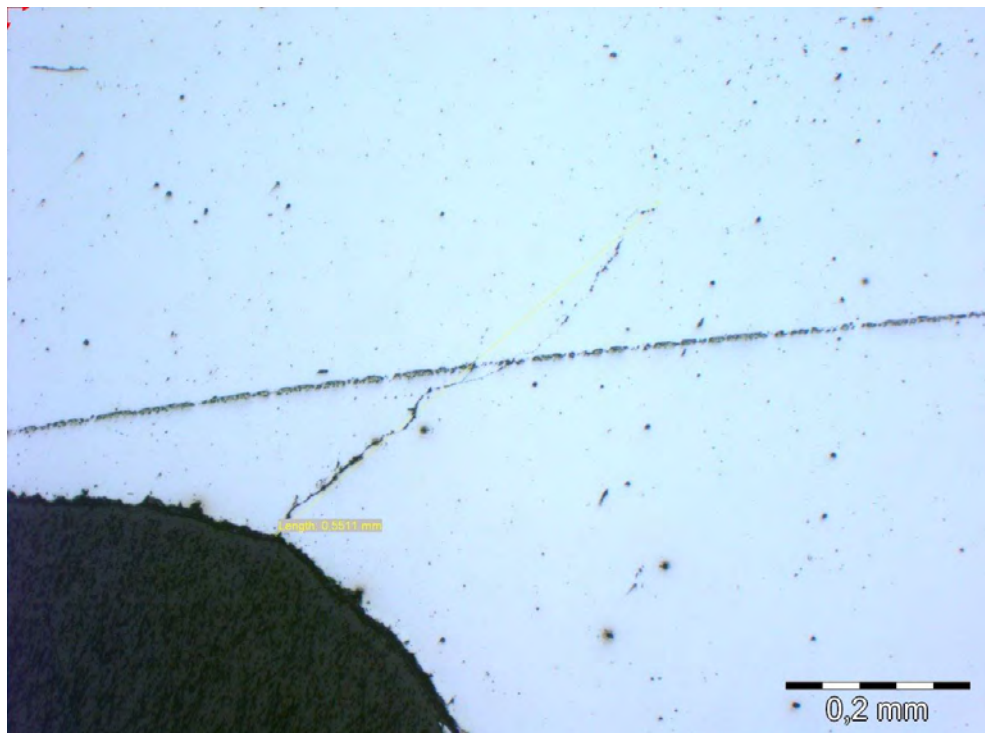
Figure C.29 Cut two in crack at segment A, first ridge on barrel no. 14389
