A study of the Browning M2 Quick Change Barrel and problems experienced in the Norwegian Armed Forces

Svein Morten Bergsrud
Pål Martin Greni

FFI report

21/00127

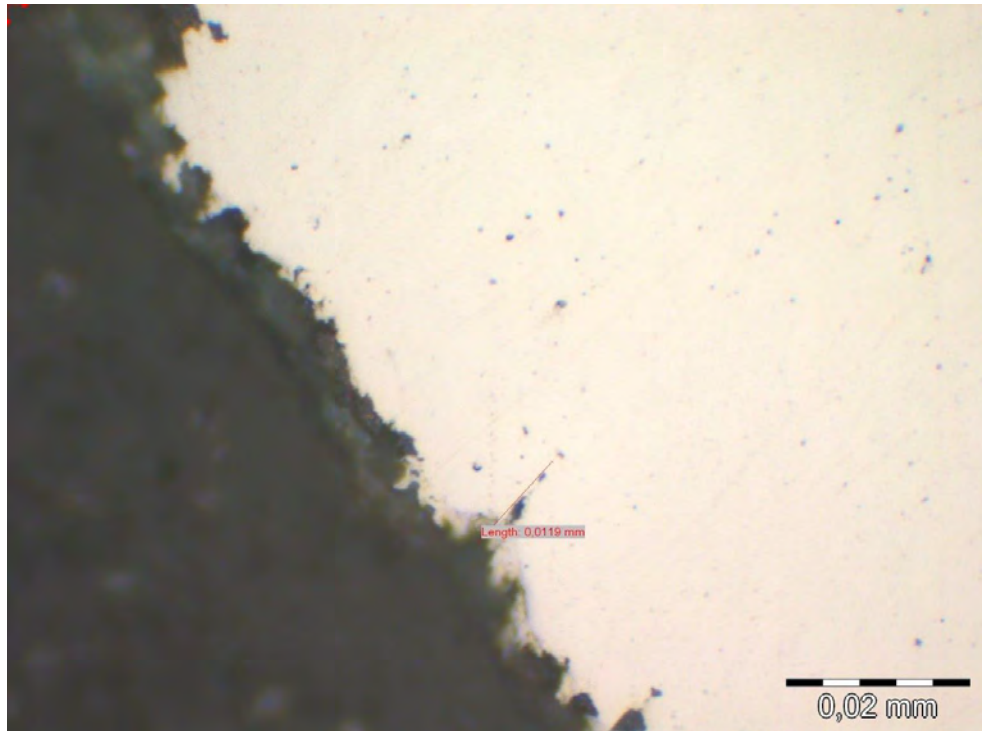
Figure C.32 Cut two in crack at segment A, fourth ridge on barrel no. 14389

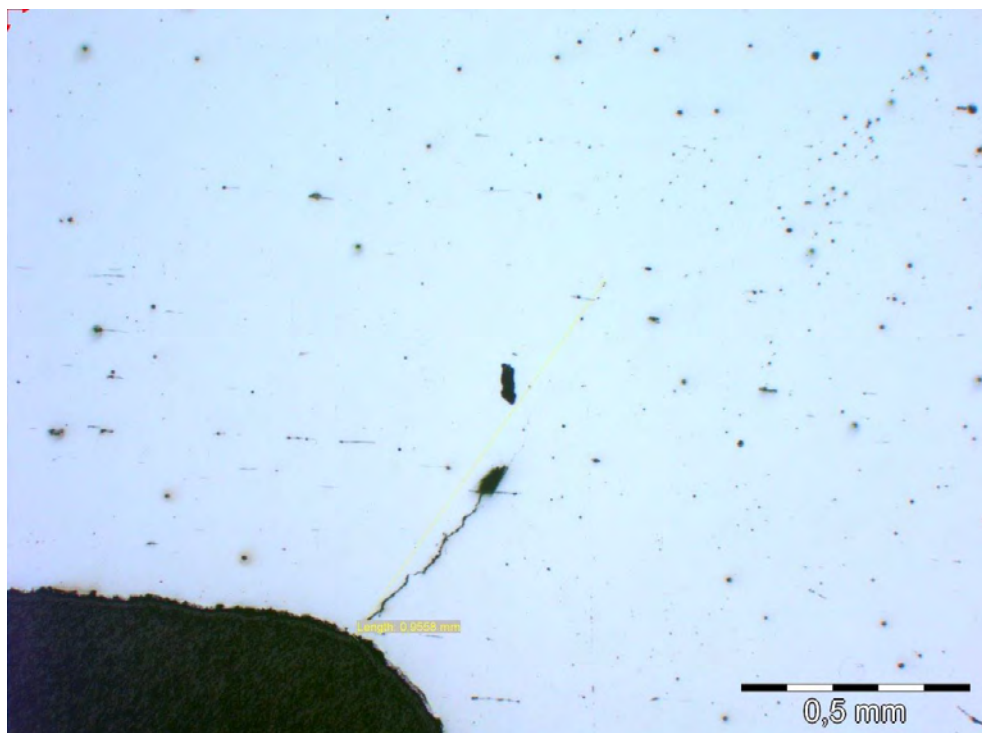
Figure C.33 Cut three in crack at segment A, first ridge on barrel no. 14389

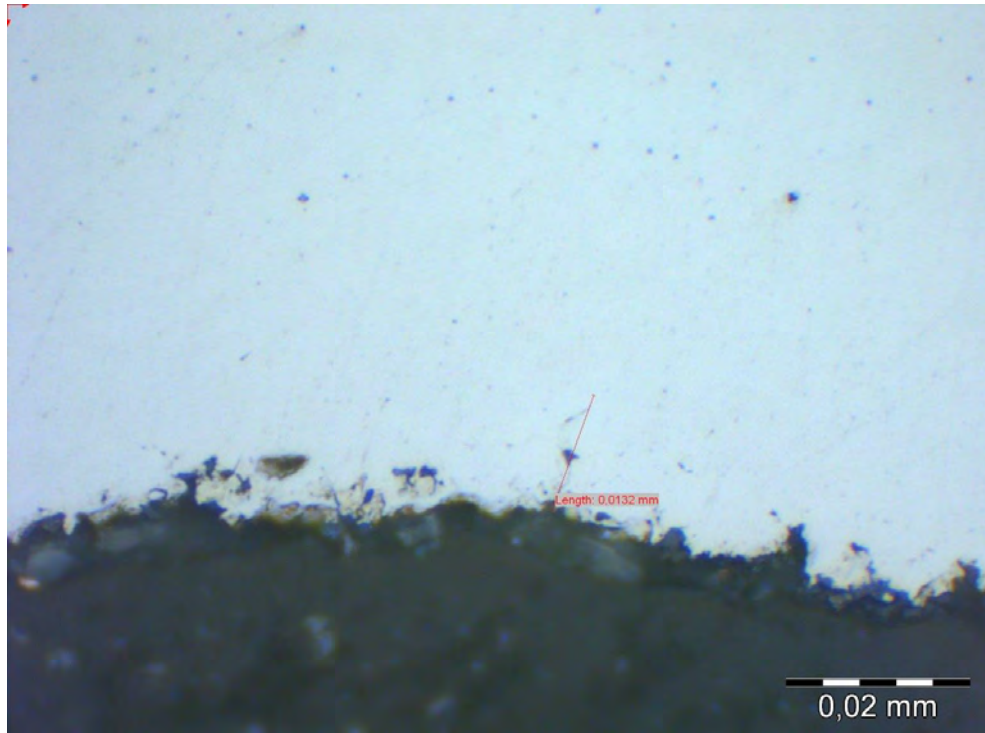
Figure C.36 Cut three in crack at segment A, fourth ridge on barrel no. 14389

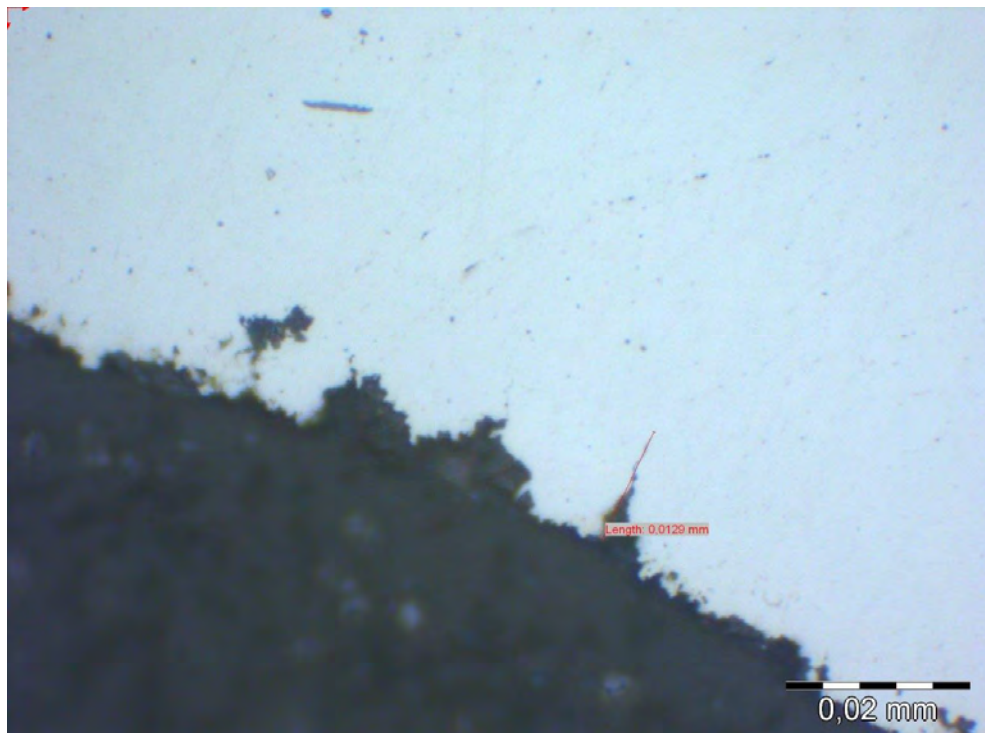
Figure C.37 Cut three in crack at segment A, fifth ridge on barrel no. 14389

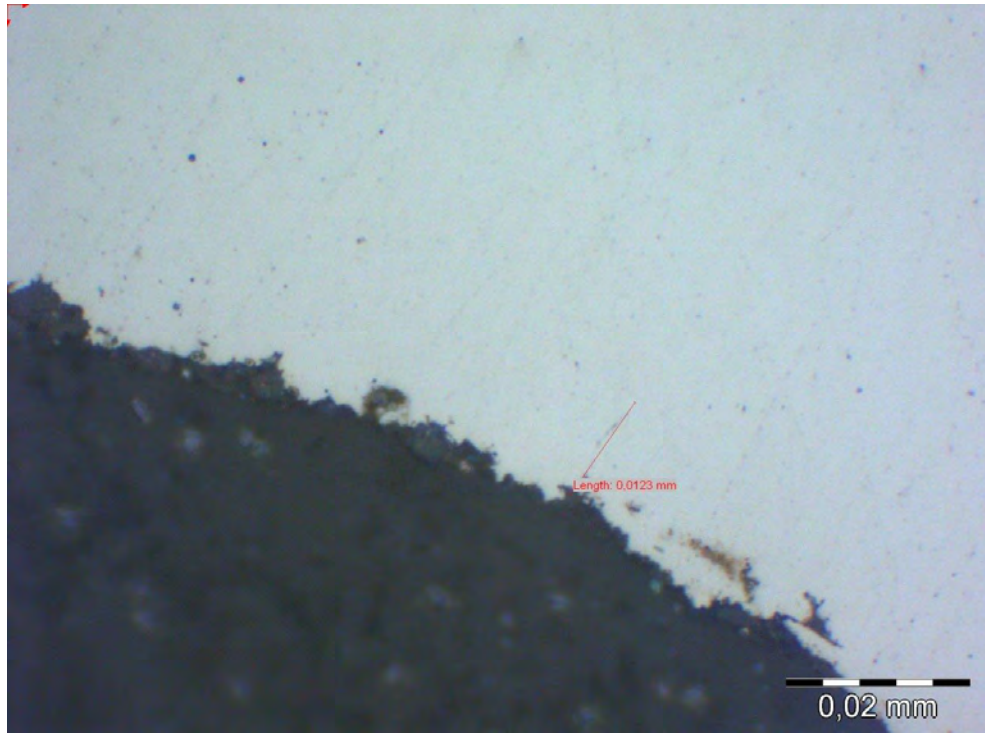
Figure C.40 Cut four in crack at segment A, fifth ridge on barrel no. 14389

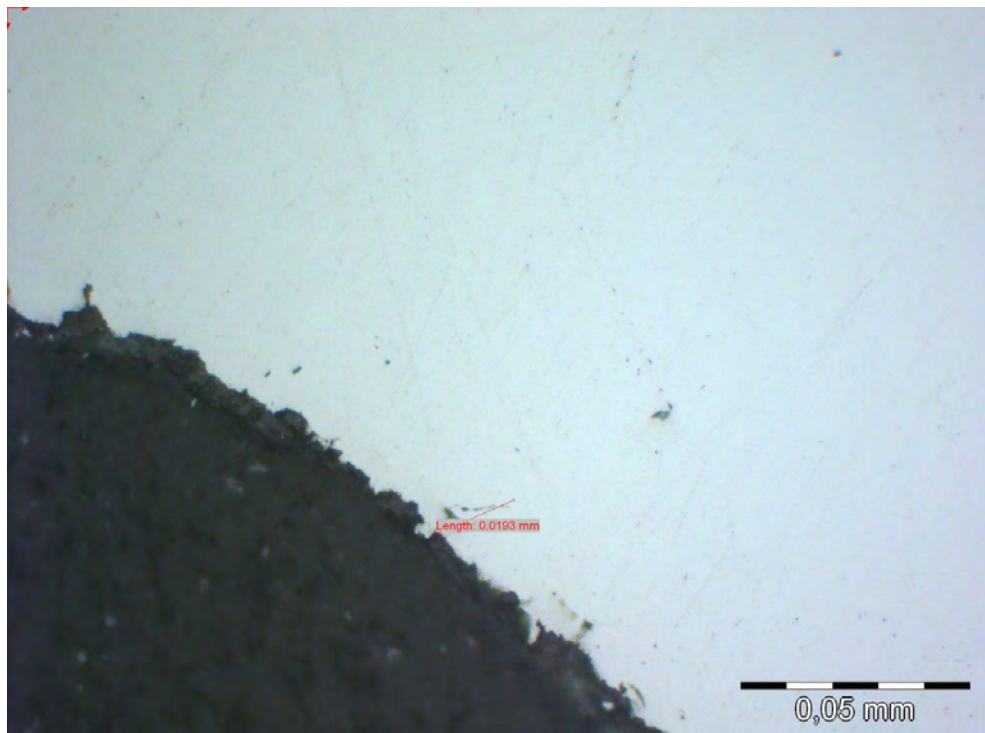
Figure C.41 Cut four in crack at segment A, fourth ridge on barrel no. 14389

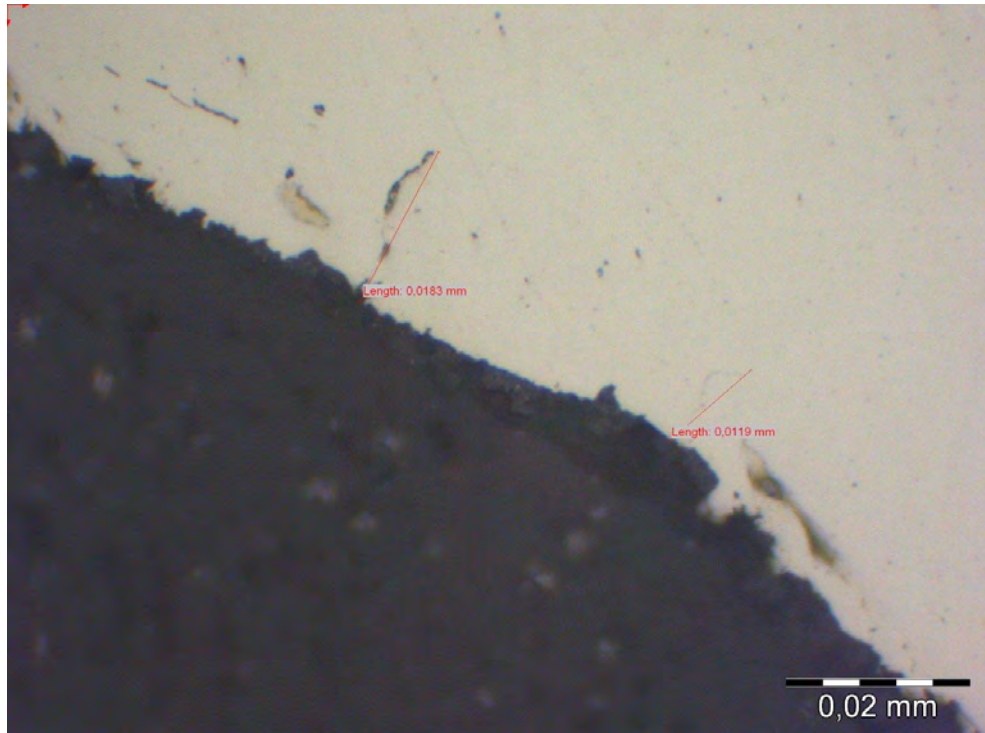
Figure C.44 Cut five in crack at segment A, third ridge on barrel no. 14389

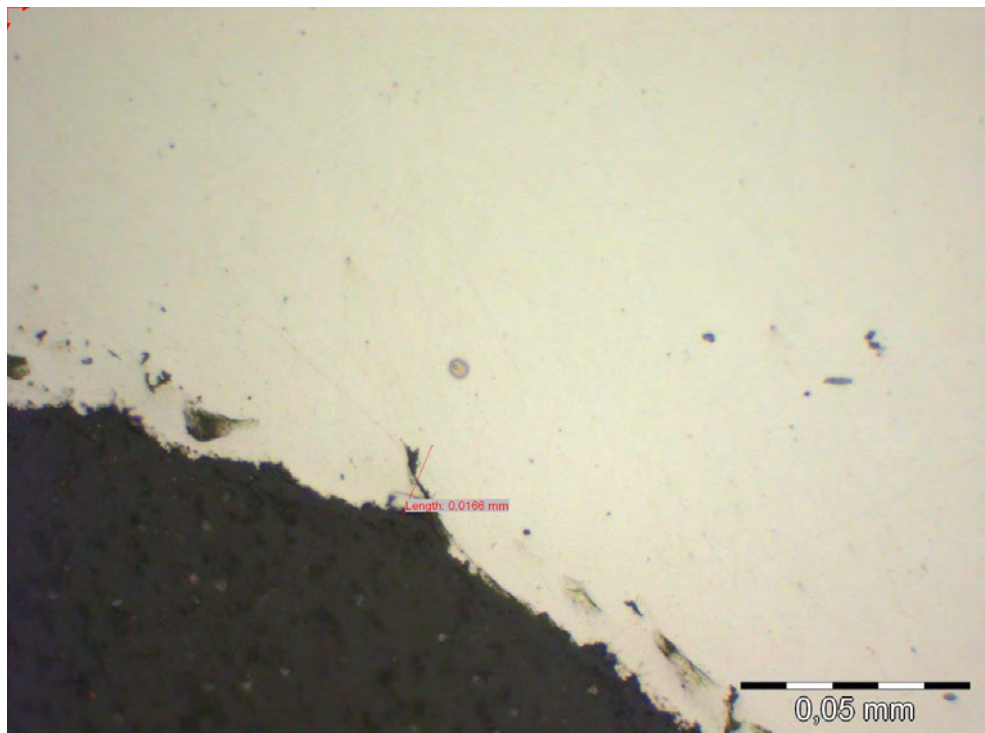
Figure C.45 Cut five in crack at segment A, fifth ridge on barrel no. 14389

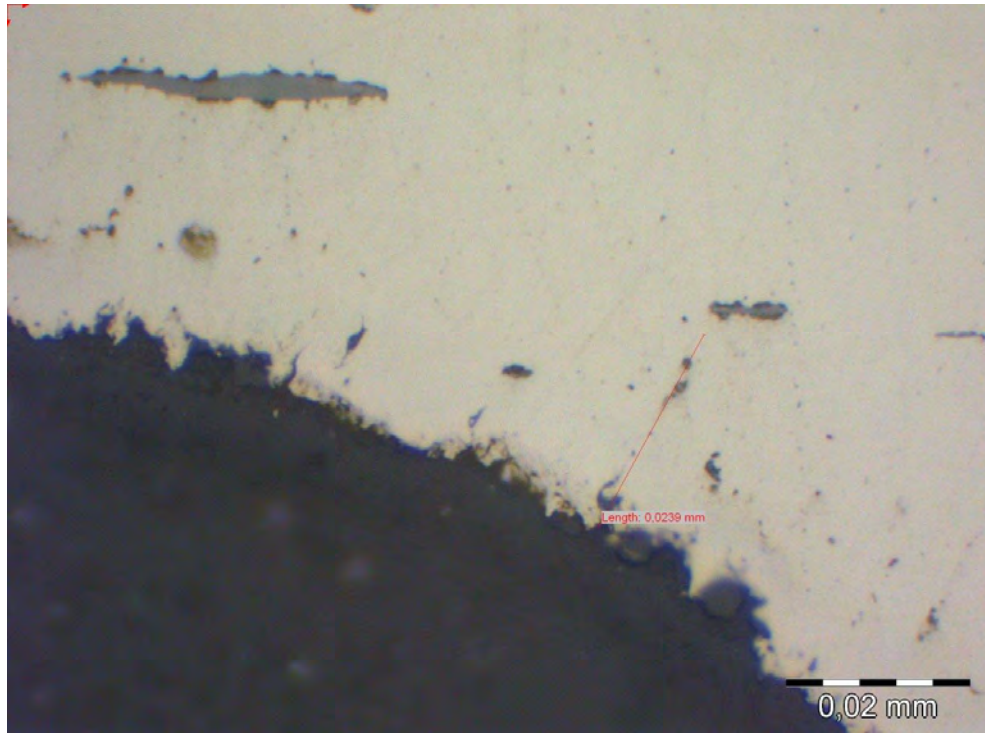
Figure C.48 Cut six in crack at segment A, fourth ridge on barrel no. 14389

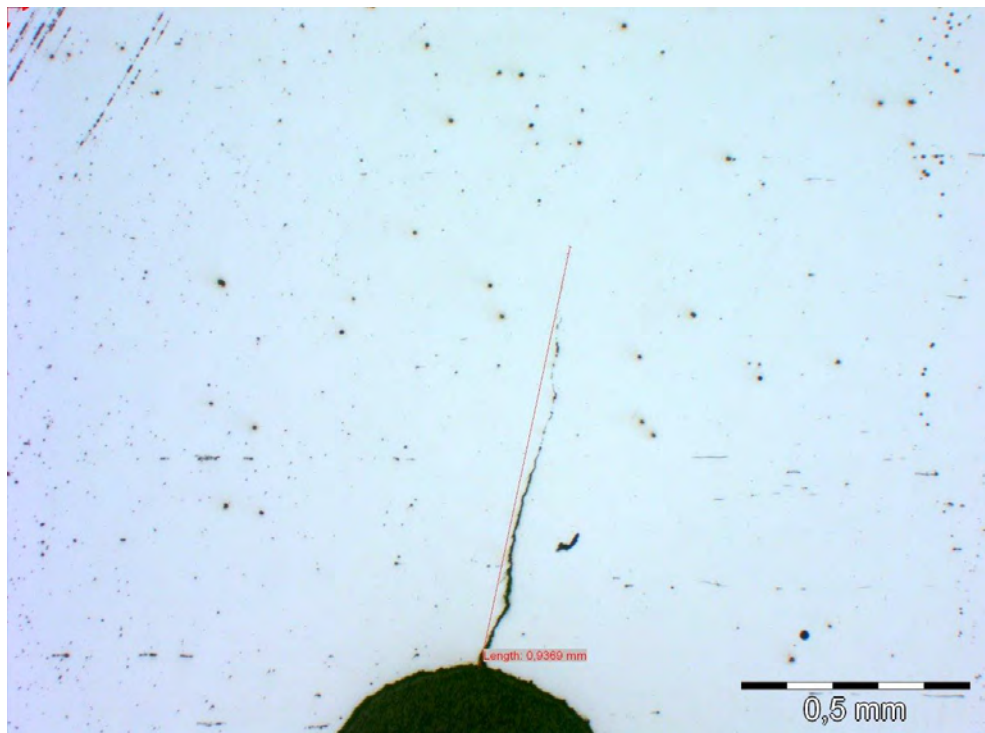
Figure C.49 Cut one in crack at segment C, second ridge on barrel no. 14389

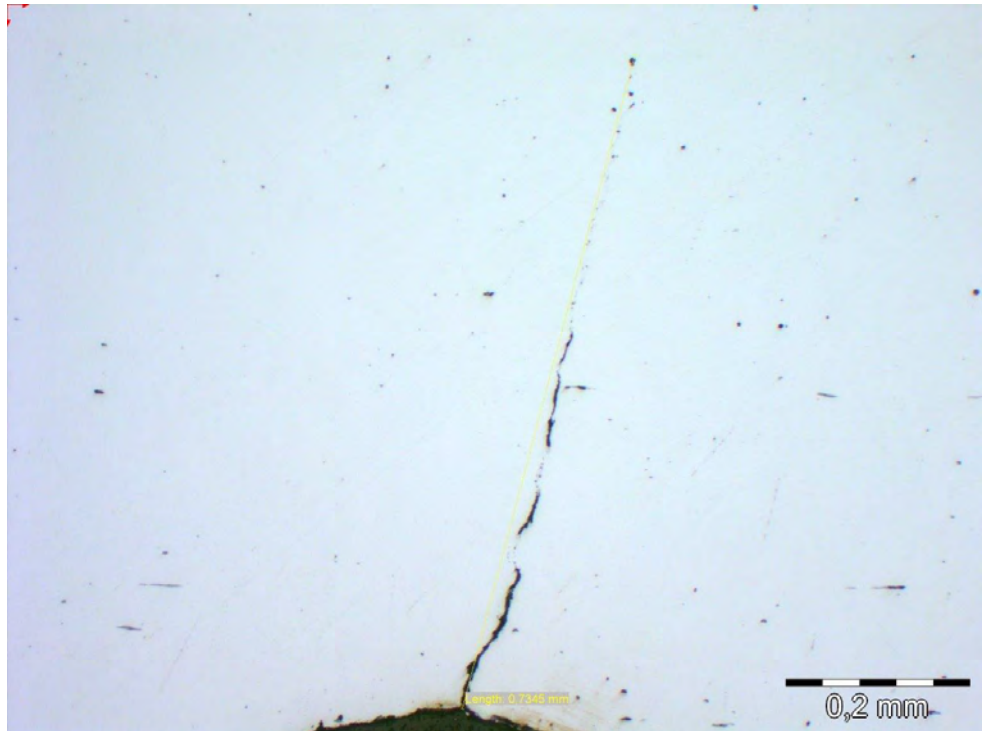
Figure C.52 Cut four in crack at segment C, second ridge on barrel no. 14389

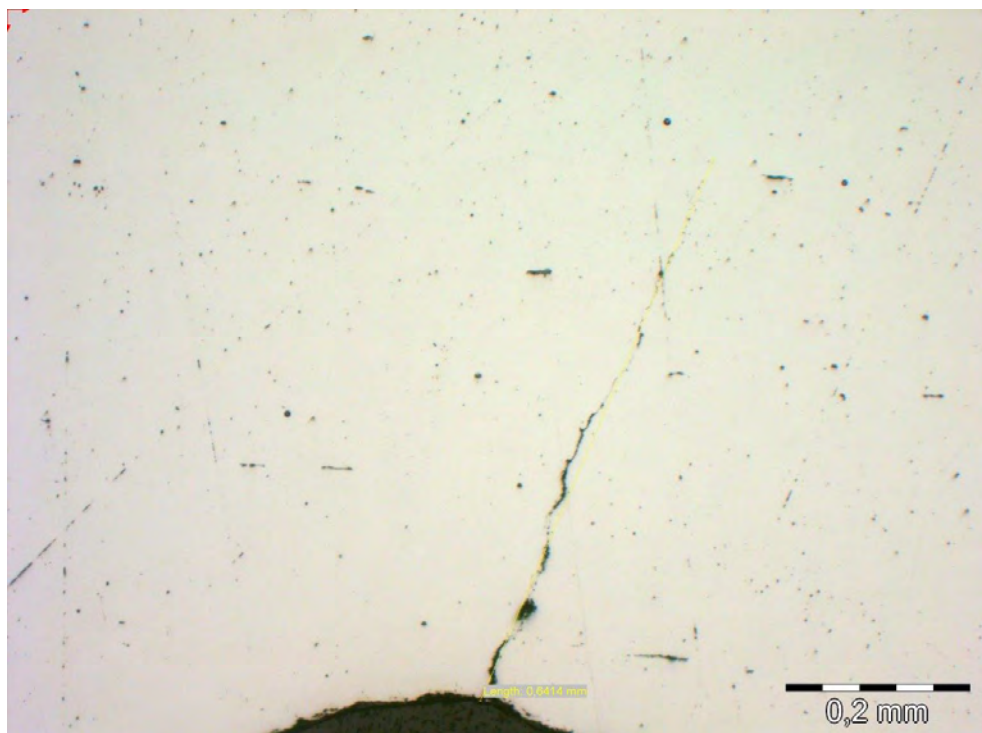
Figure C.53 Cut five in crack at segment C, second ridge on barrel no. 14389

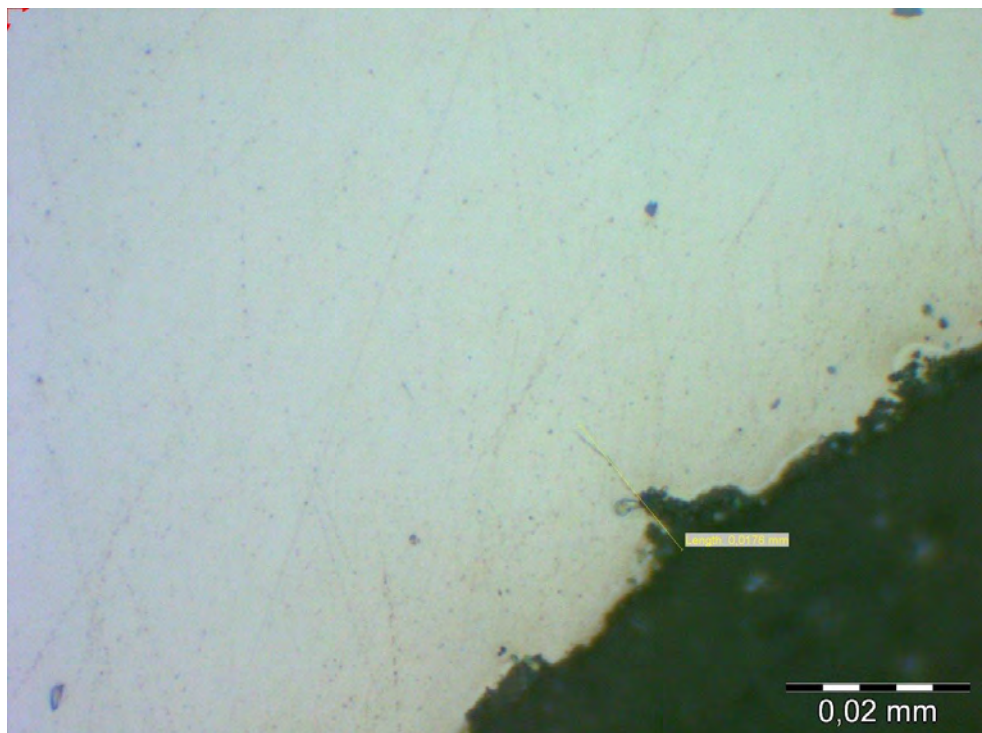
Figure C.55 Cut one in crack at segment C, third ridge on barrel no. 14389

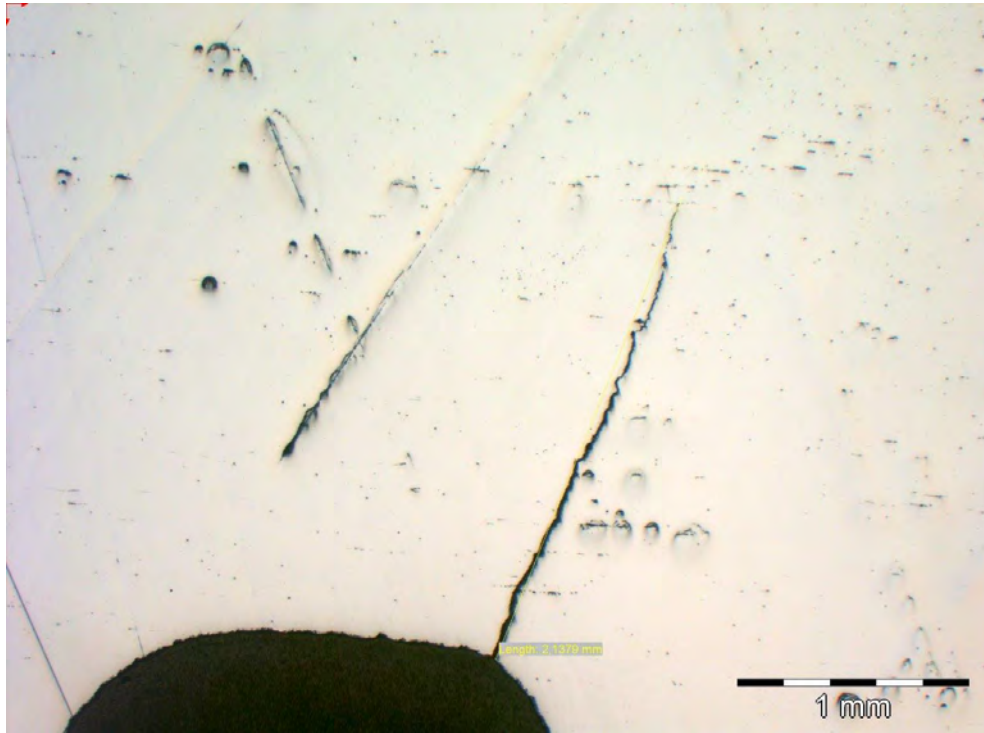
Figure C.58 Crack at segment A, first ridge on barrel no. 14389

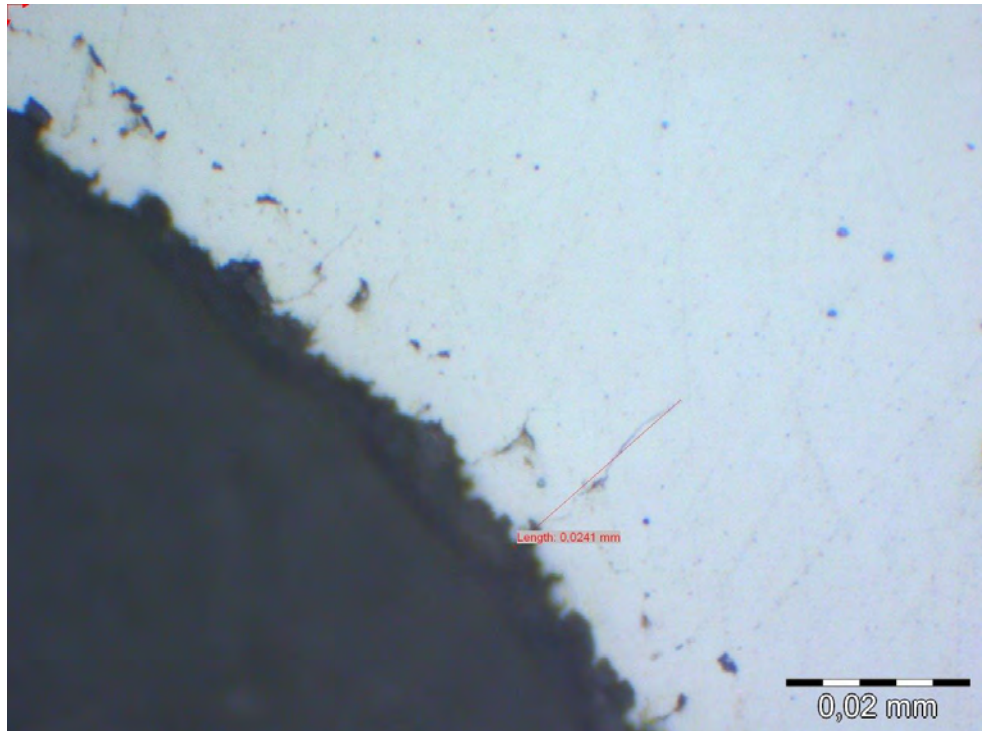
Figure C.61 Crack at segment A, third ridge on barrel no. 14389

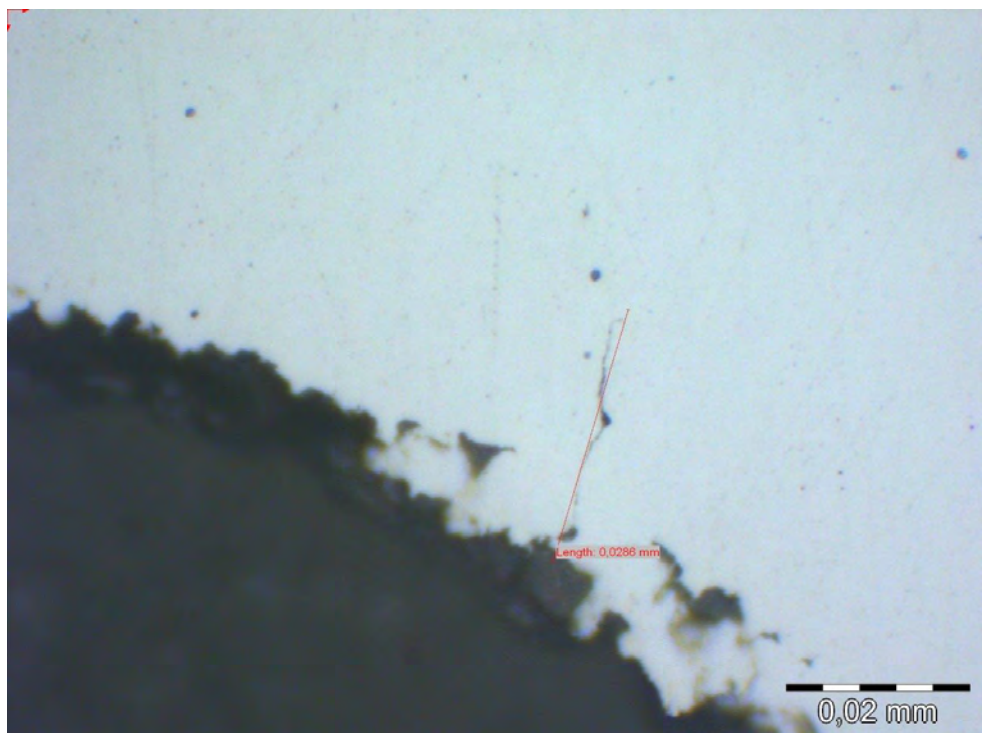
Figure C.62 Crack at segment A, fourth ridge on barrel no. 14389

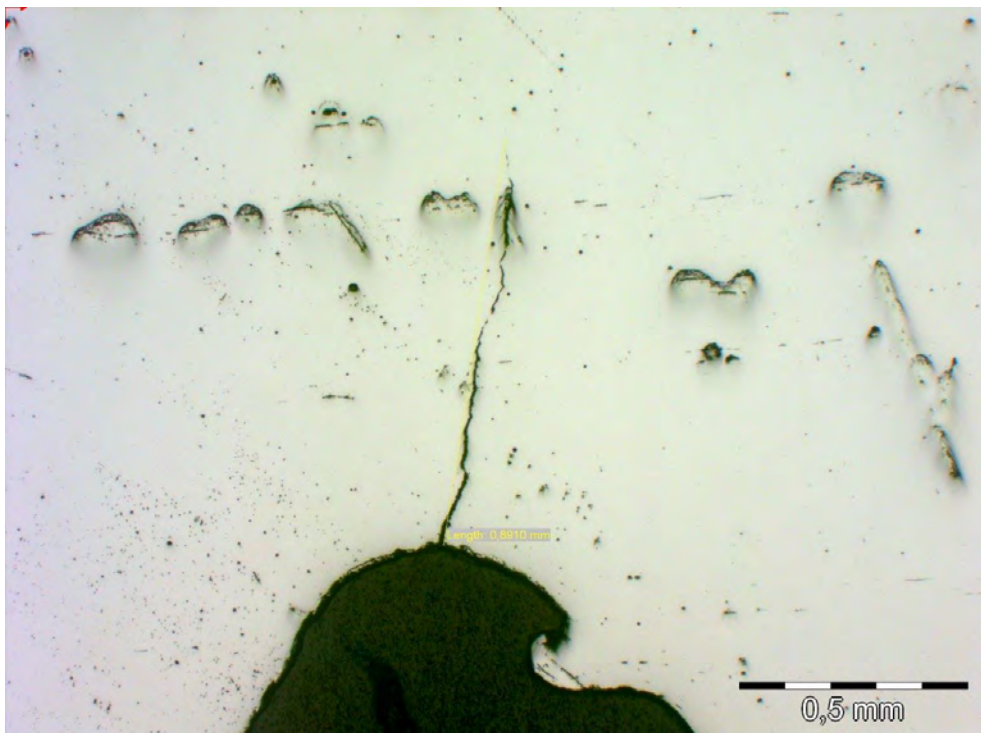
Figure C.64 Crack at segment C, second ridge on barrel no. 14389

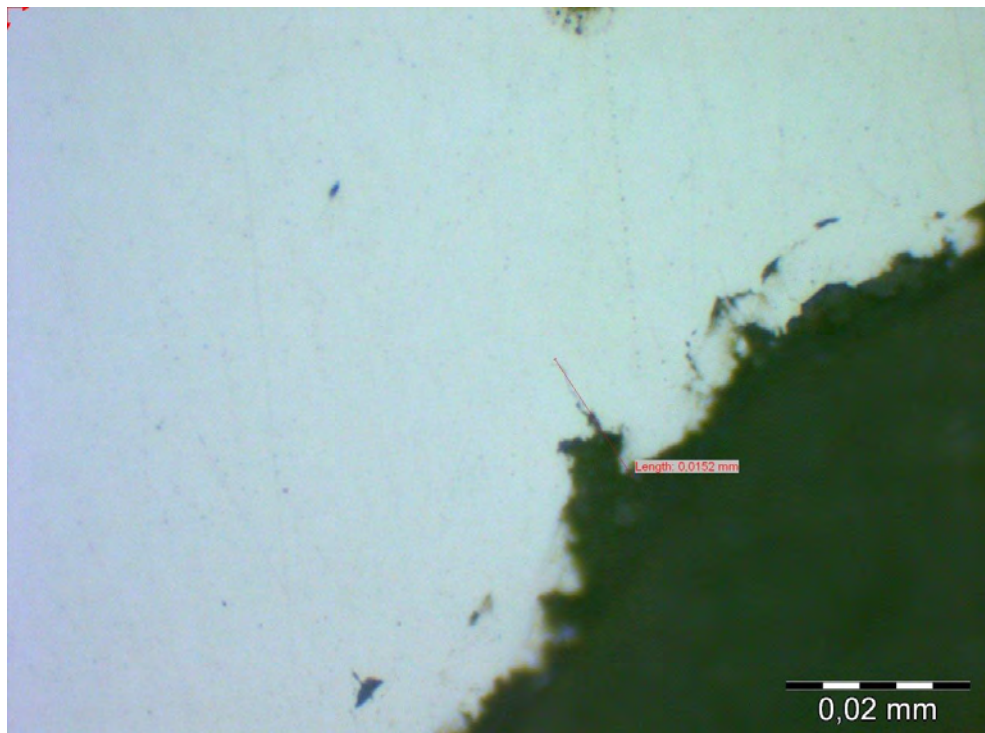
Figure C.65 Crack at segment C, third ridge on barrel no. 14389

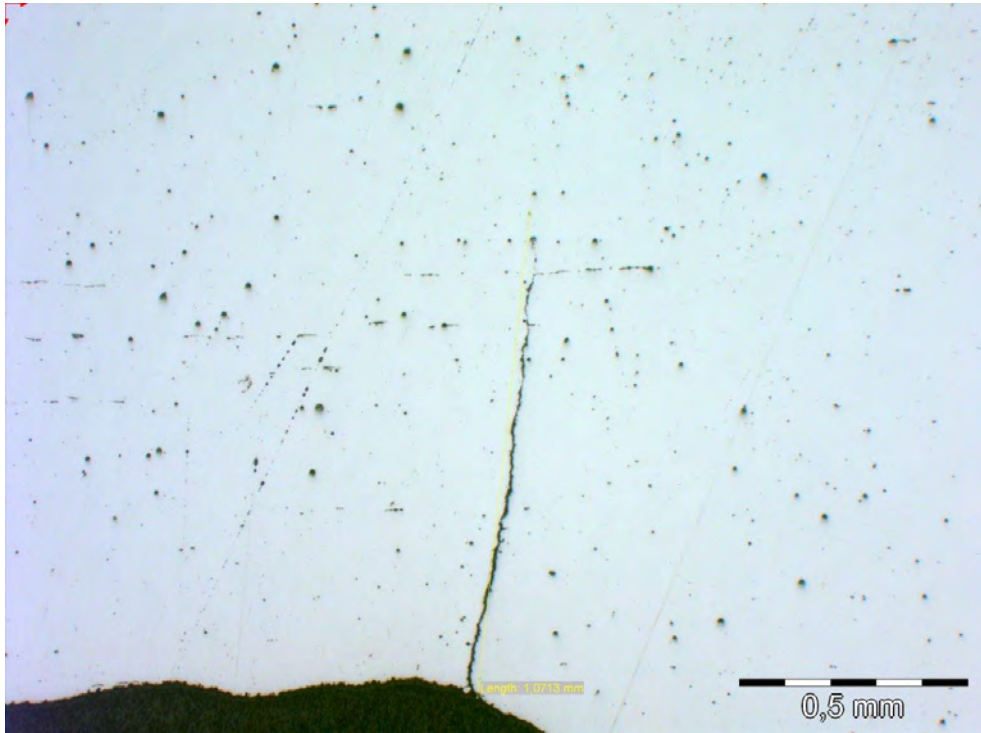
Figure C.66 Cut one in crack at segment A, first ridge on barrel no. SFK 0120-A

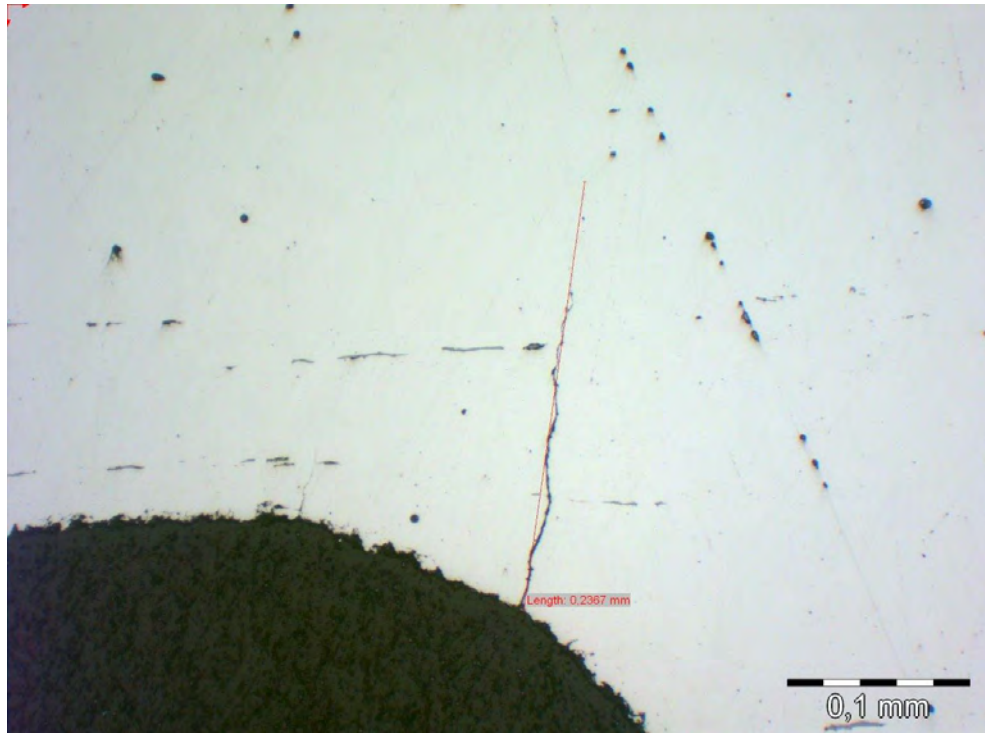
Figure C.67 Cut one in crack at segment A, second ridge on barrel no. SFK 0120-A

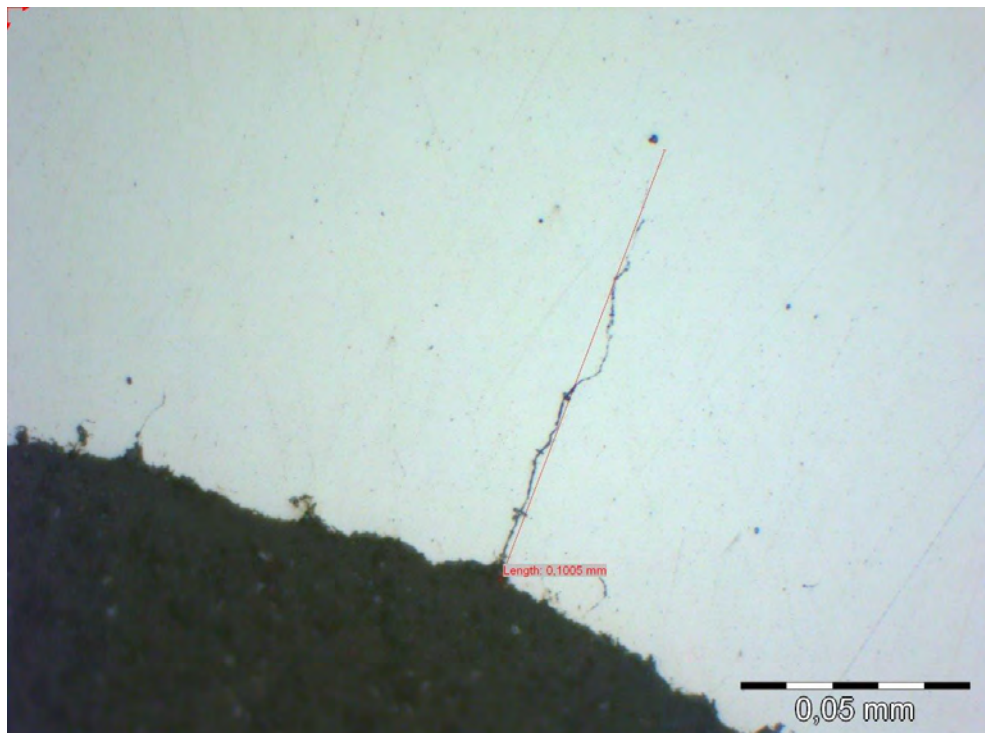
Figure C.68 Cut one in crack at segment A, third ridge on barrel no. SFK 0120-A

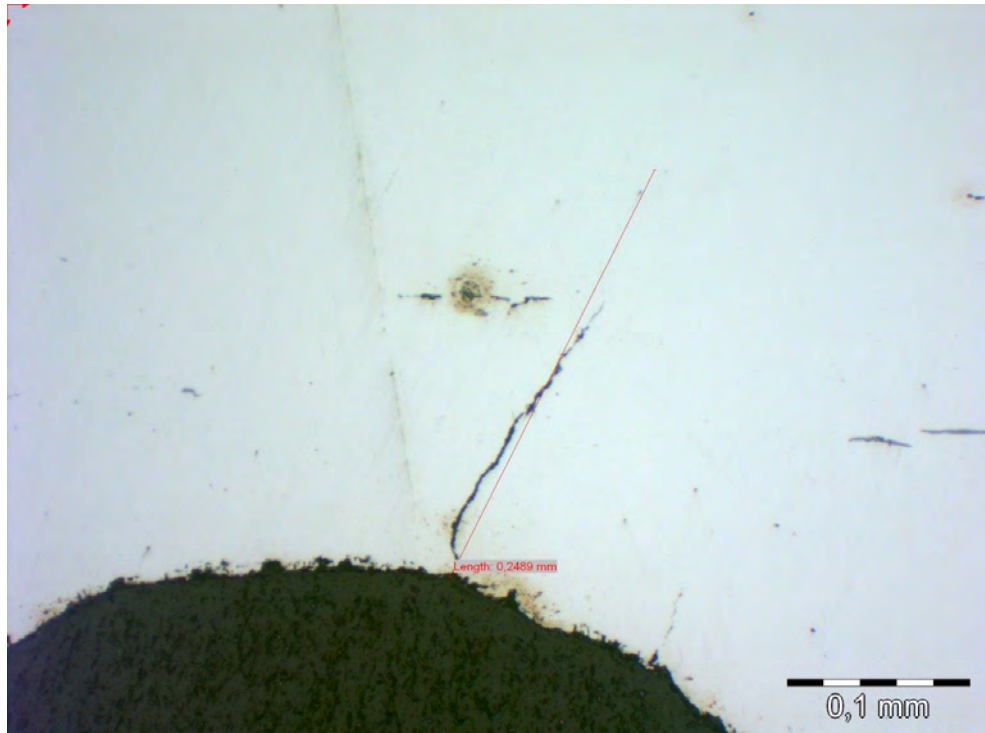
Figure C.71 Cut two in crack at segment B, second ridge on barrel no. SFK 0120-A

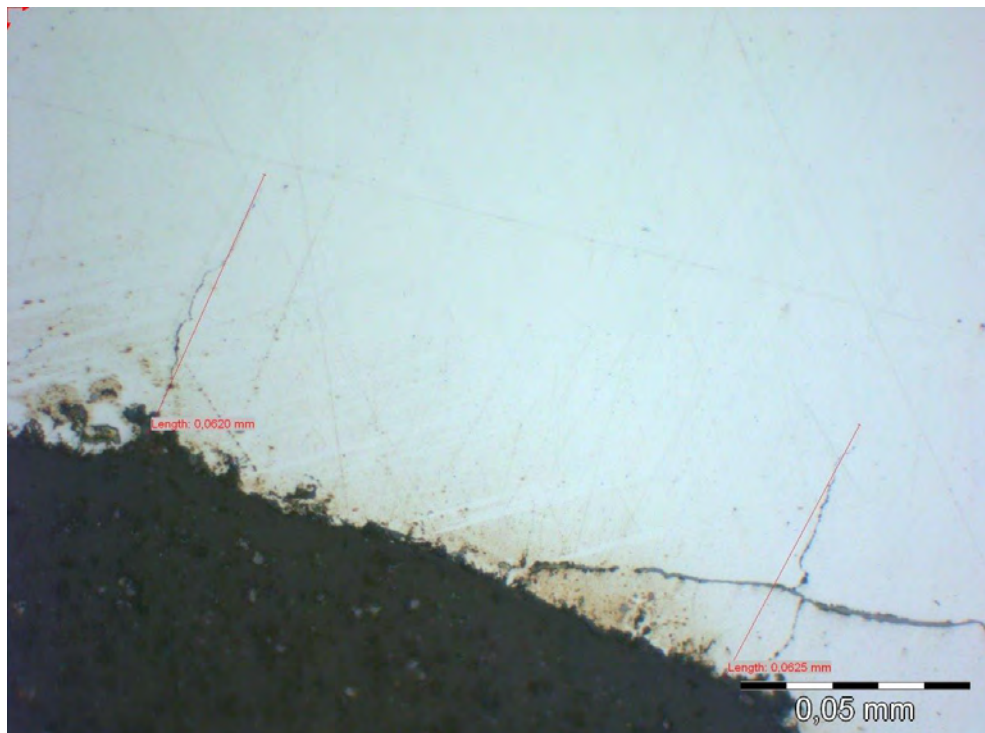
Figure C.72 Cut two in crack at segment B, third ridge on barrel no. SFK 0120-A

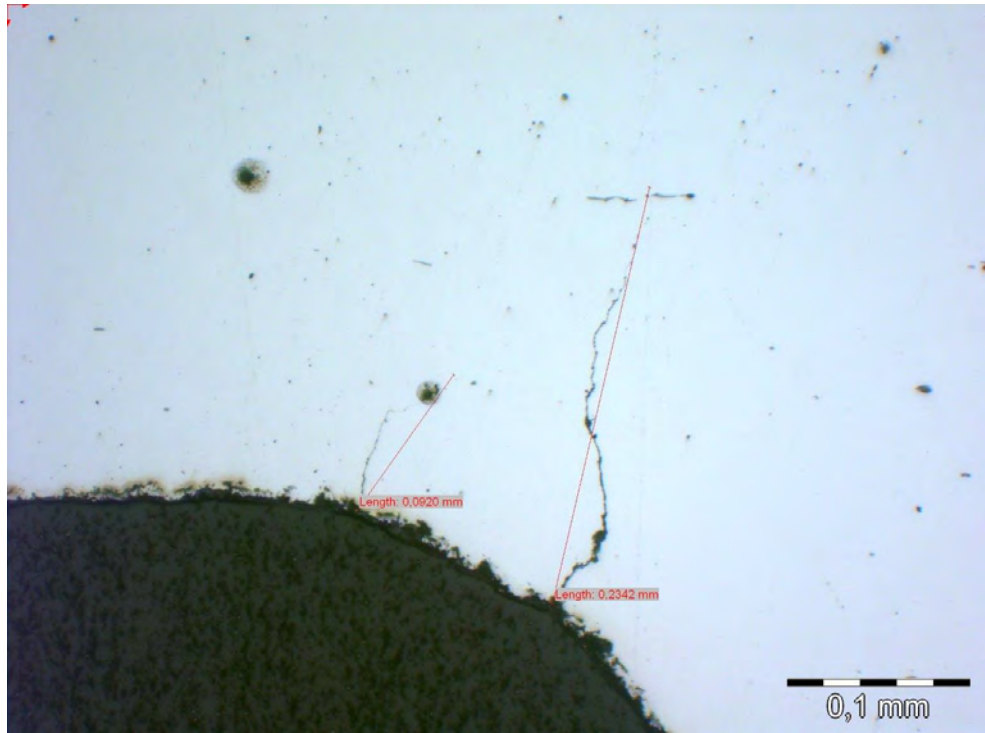
Figure C.75 Cut three in crack at segment A, second ridge on barrel no. SFK 0120-A

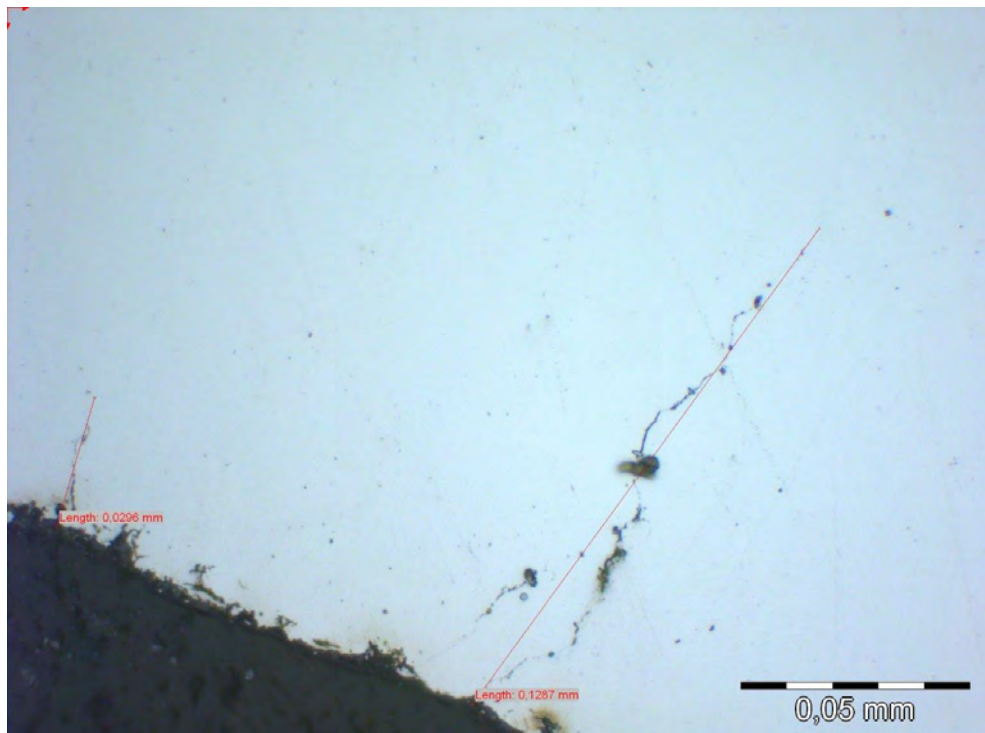
Figure C.76 Cut three in crack at segment A, third ridge on barrel no. SFK 0120-A

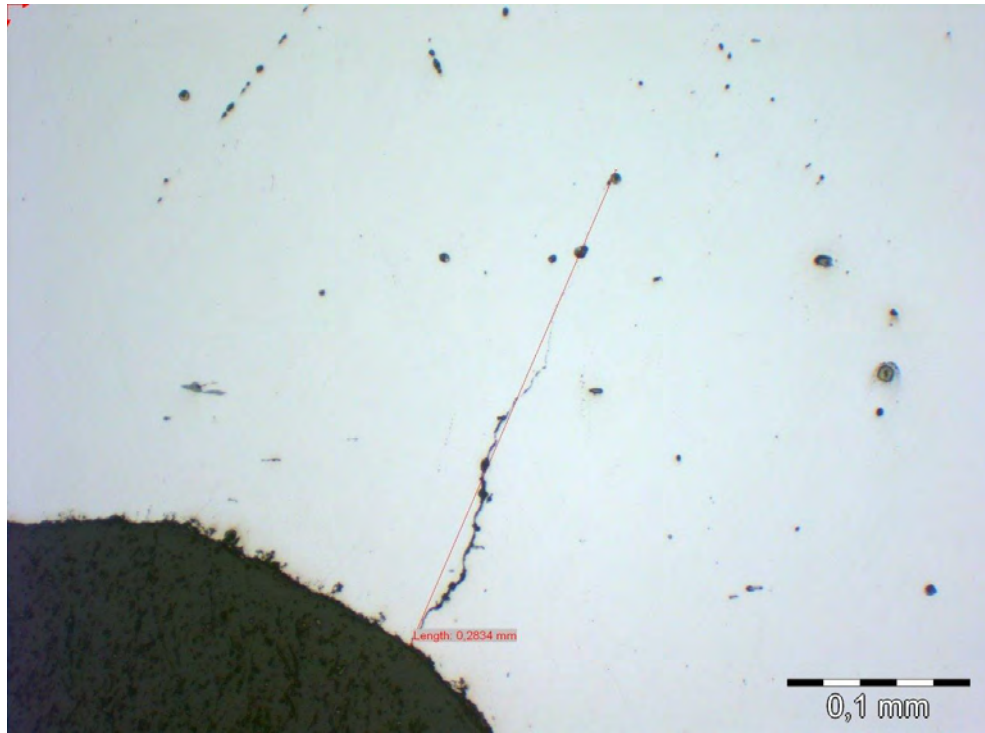
Figure C.79 Cut four in crack at segment B, second ridge on barrel no. SFK 0120-A

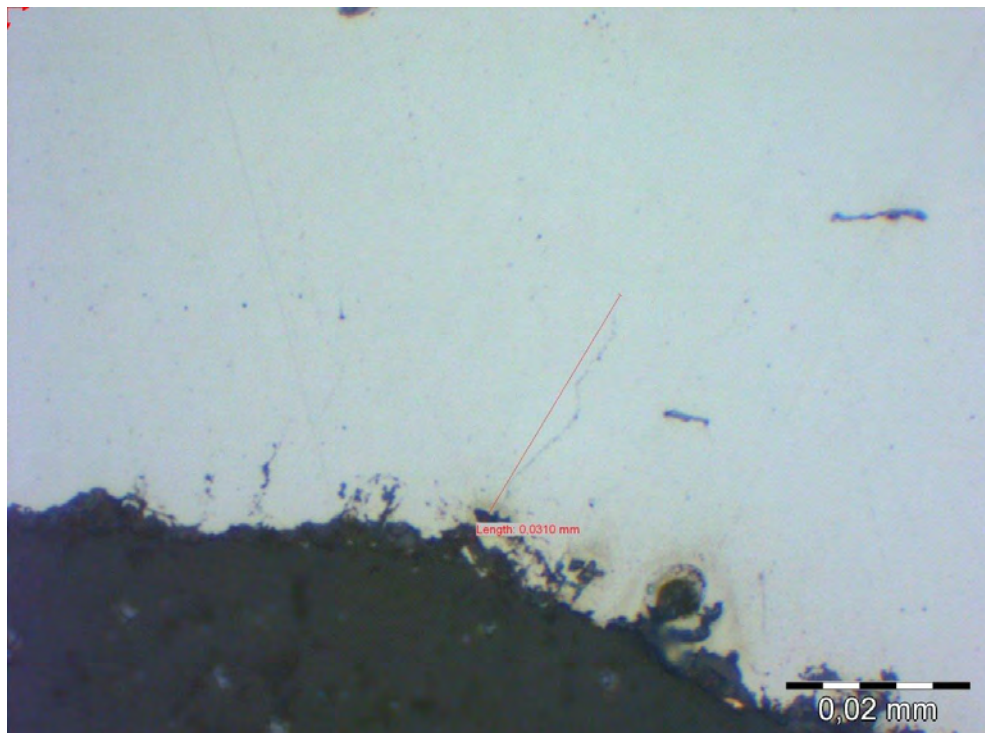
Figure C.80 Cut four in crack A at segment B, third ridge on barrel no. SFK 0120-A

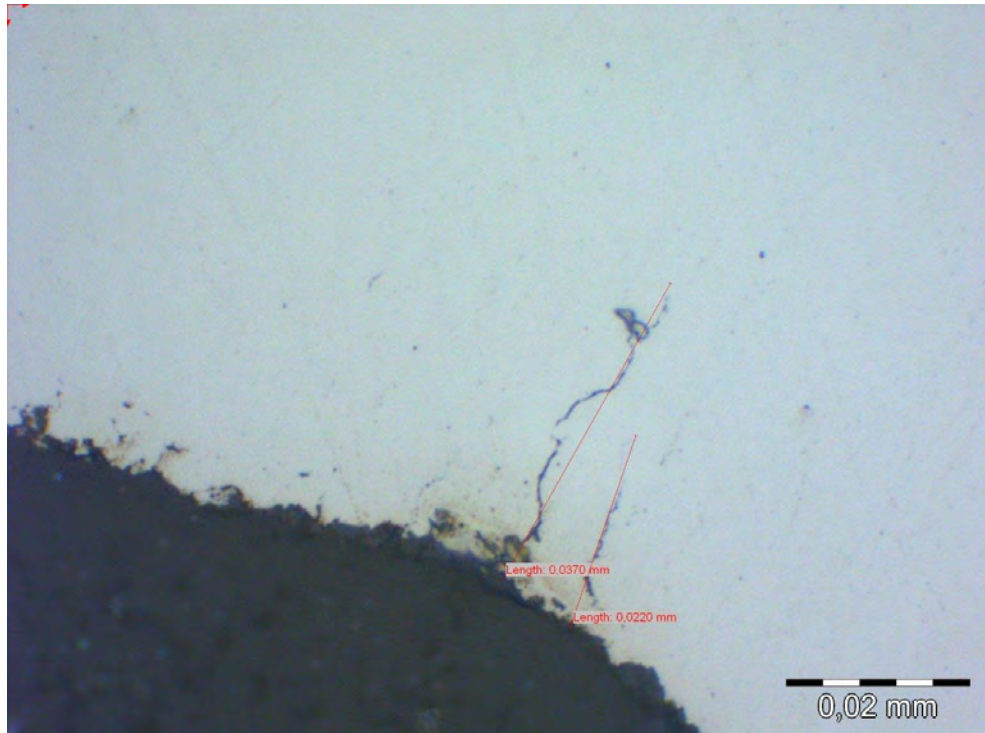
Figure C.83 Cut four in crack at segment B, fifth ridge on barrel no. SFK 0120-A

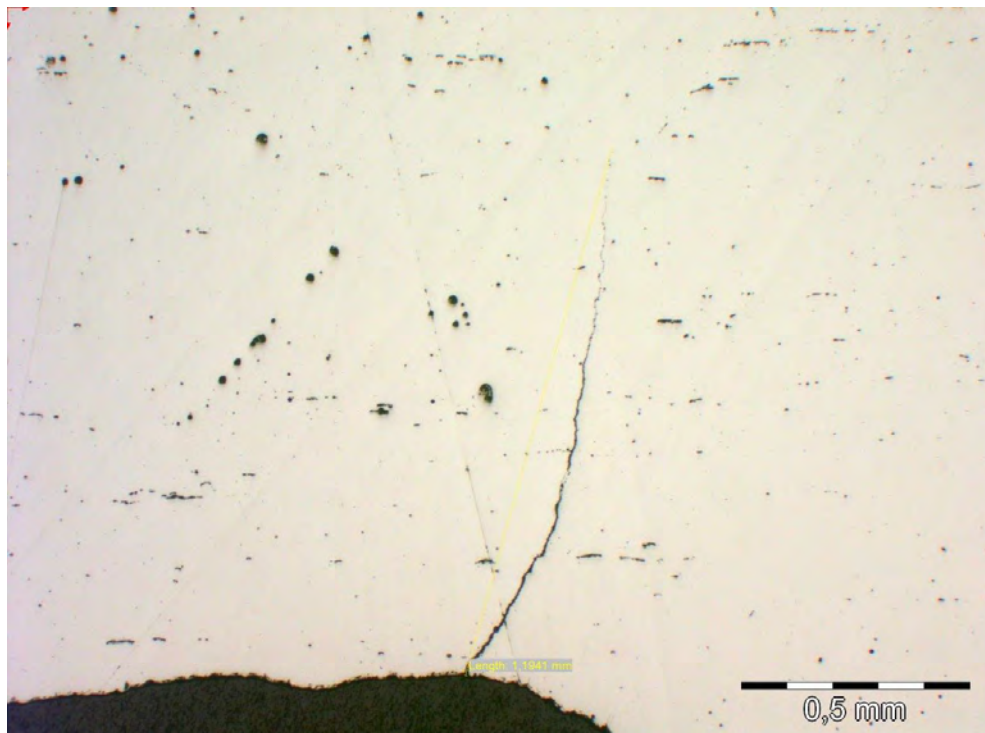
Figure C.84 Cut five in crack at segment B, first ridge on barrel no. SFK 0120-A

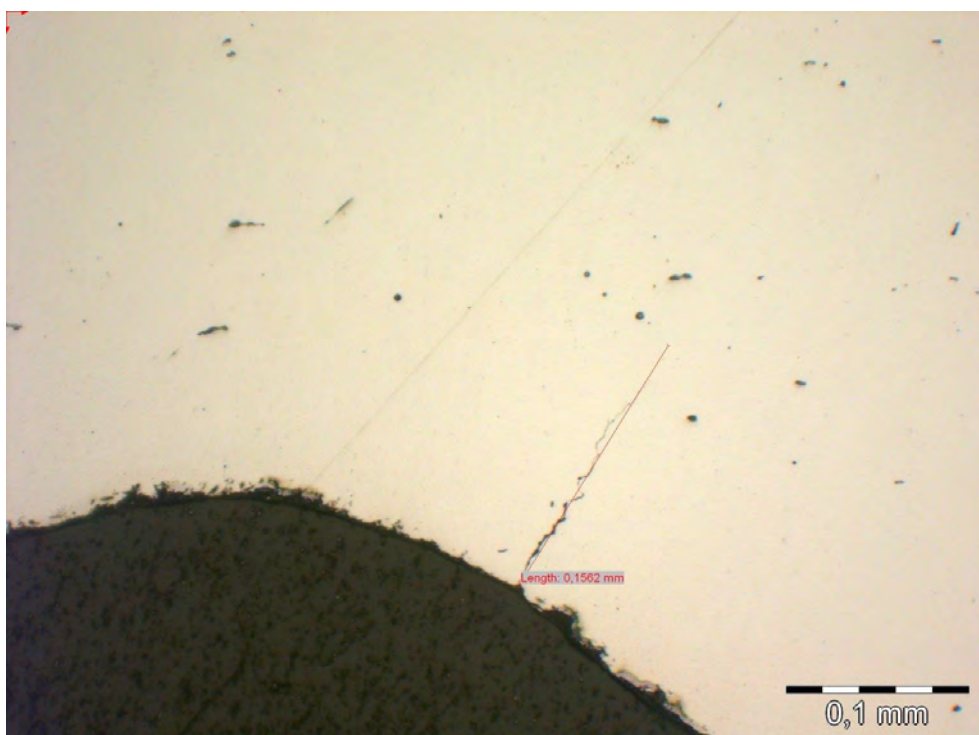
Figure C.86 Cut five in crack at segment B, third ridge on barrel no. SFK 0120-A

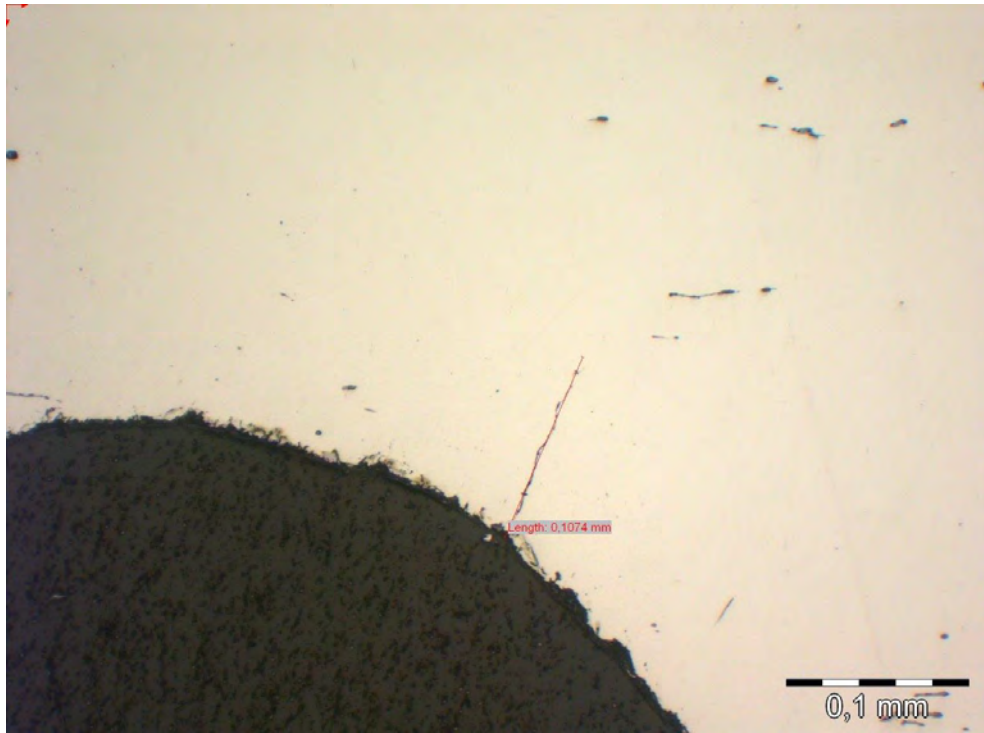
Figure C.87 Cut five in crack at segment B, fourth ridge on barrel no. SFK 0120-A
