A study of the Browning M2 Quick Change Barrel and problems experienced in the Norwegian Armed Forces

Svein Morten Bergsrud
Pål Martin Greni

FFI report

21/00127

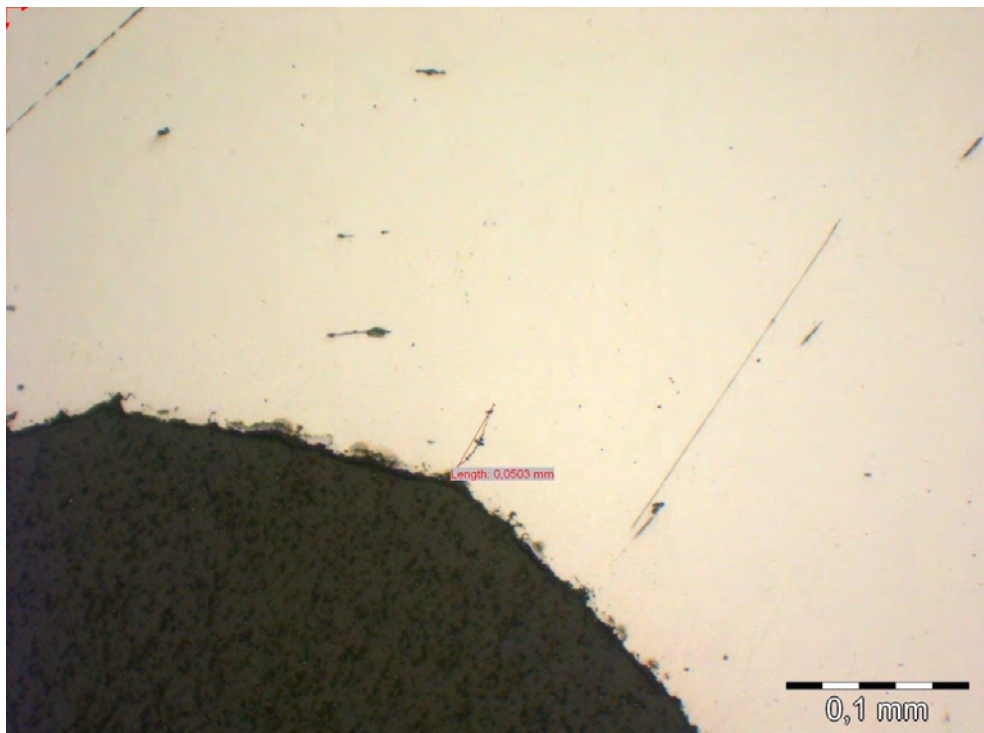
Figure C.88 Cut five in crack at segment B, fifth ridge on barrel no. SFK 0120-A

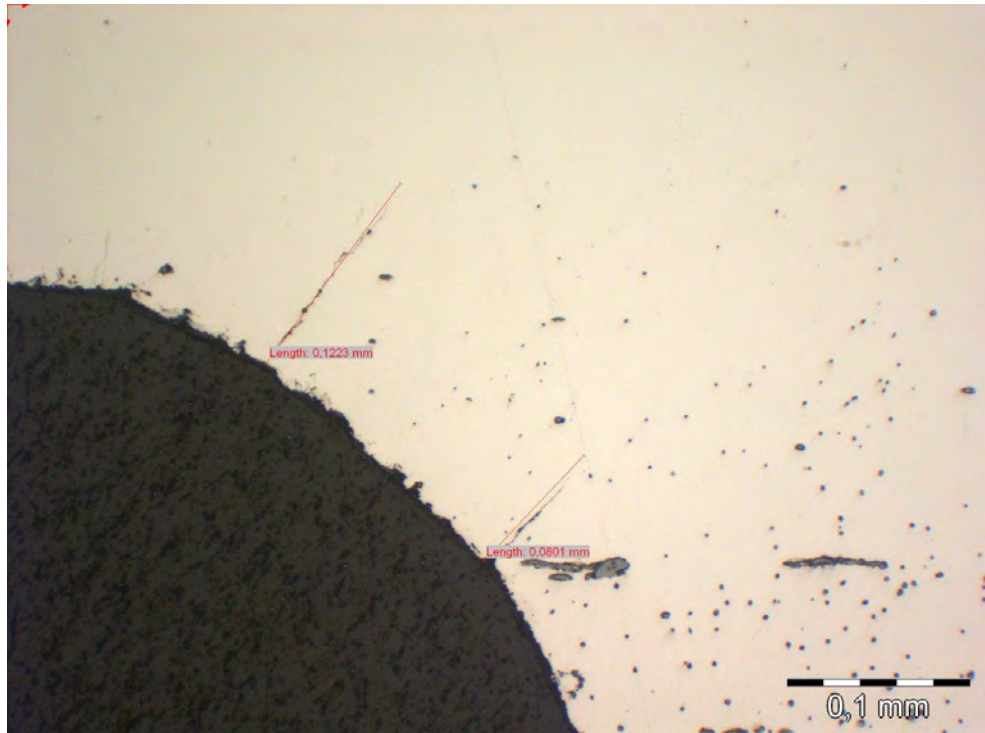
Figure C.91 Cut six in crack at segment B, third ridge on barrel no. SFK 0120-A

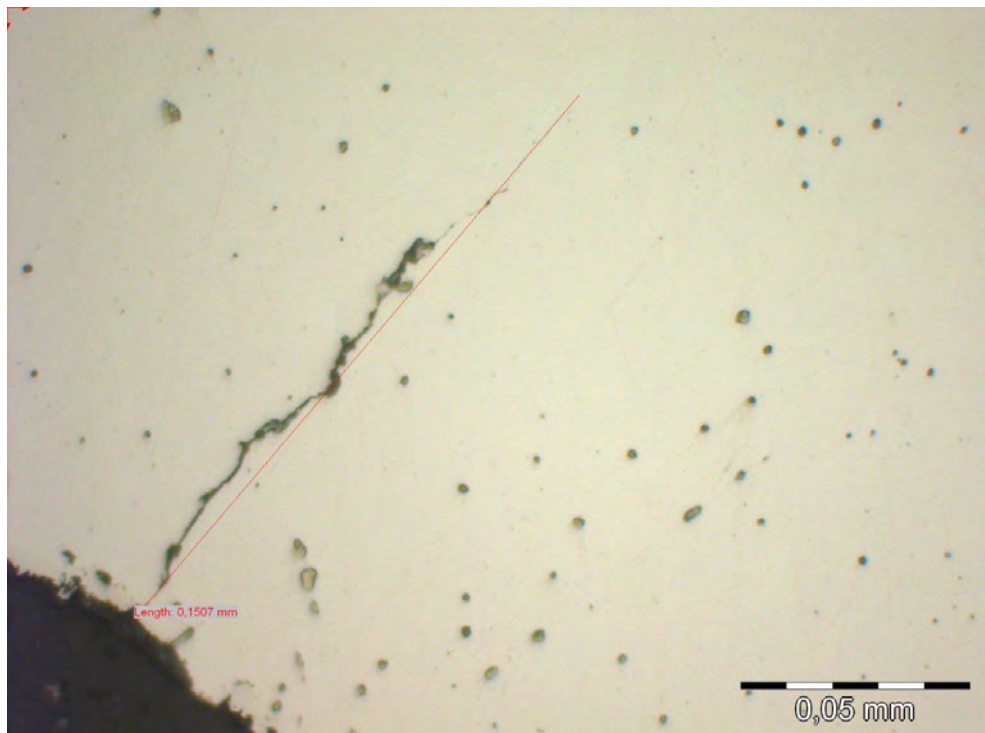
Figure C.92 Cut six in crack at segment B, fourth ridge on barrel no. SFK 0120-A

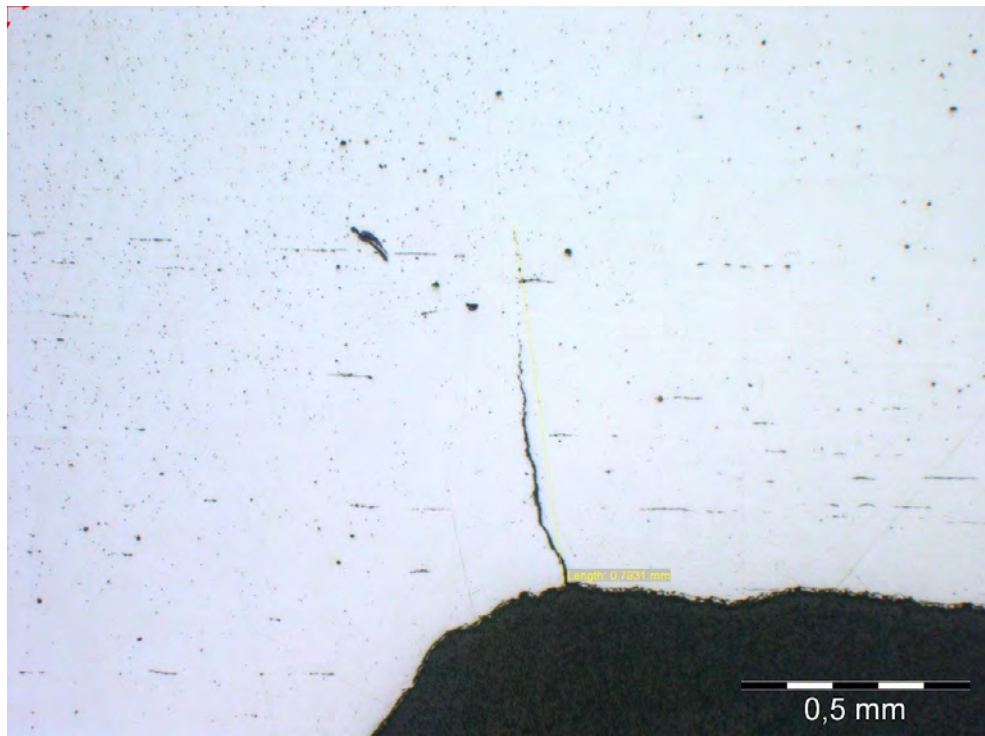
Figure C.94 Crack at segment A, first ridge on barrel no. SFK 0120-A

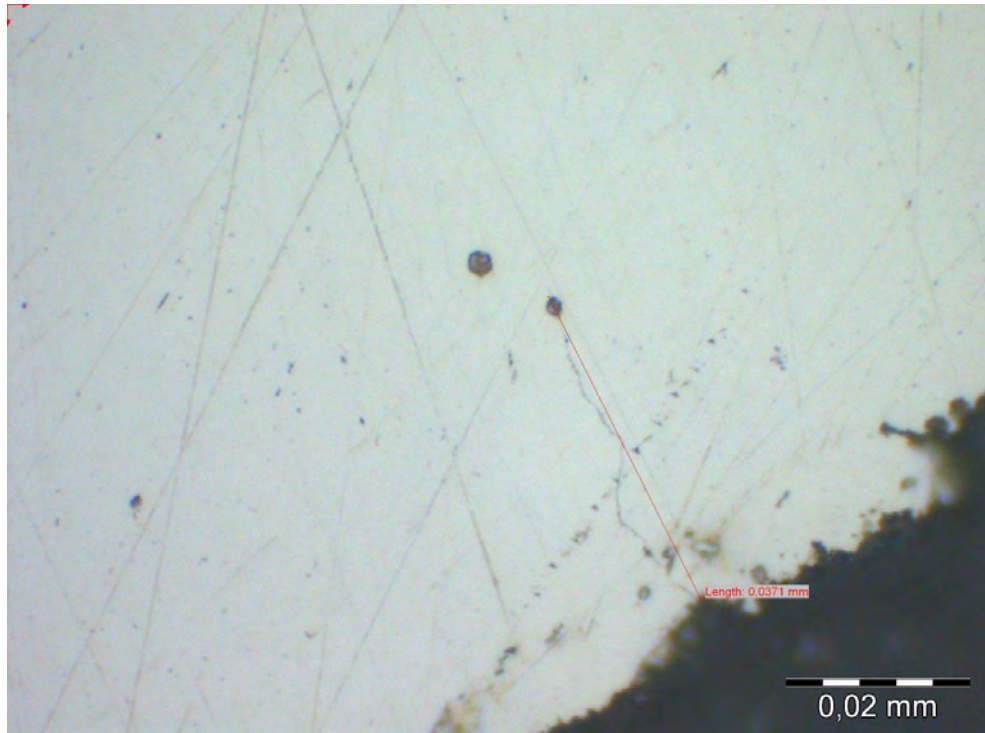
Figure C.97 Crack at segment A, fourth ridge on barrel no. SFK 0120-A

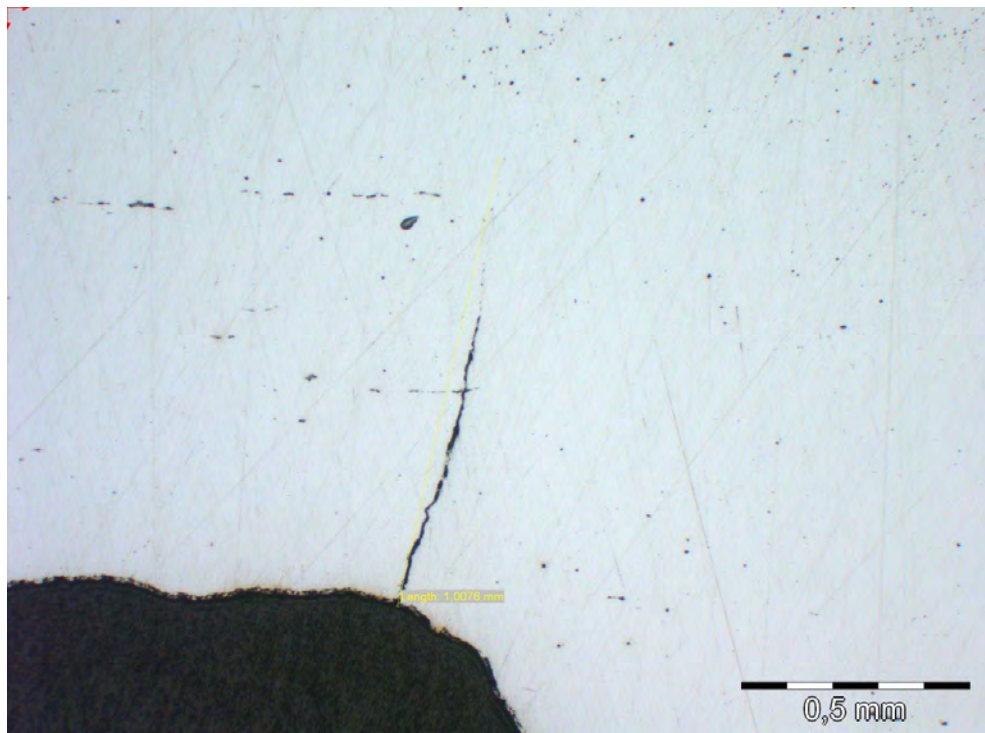
Figure C.98 Crack at segment B, first ridge on barrel no. SFK 0120-A

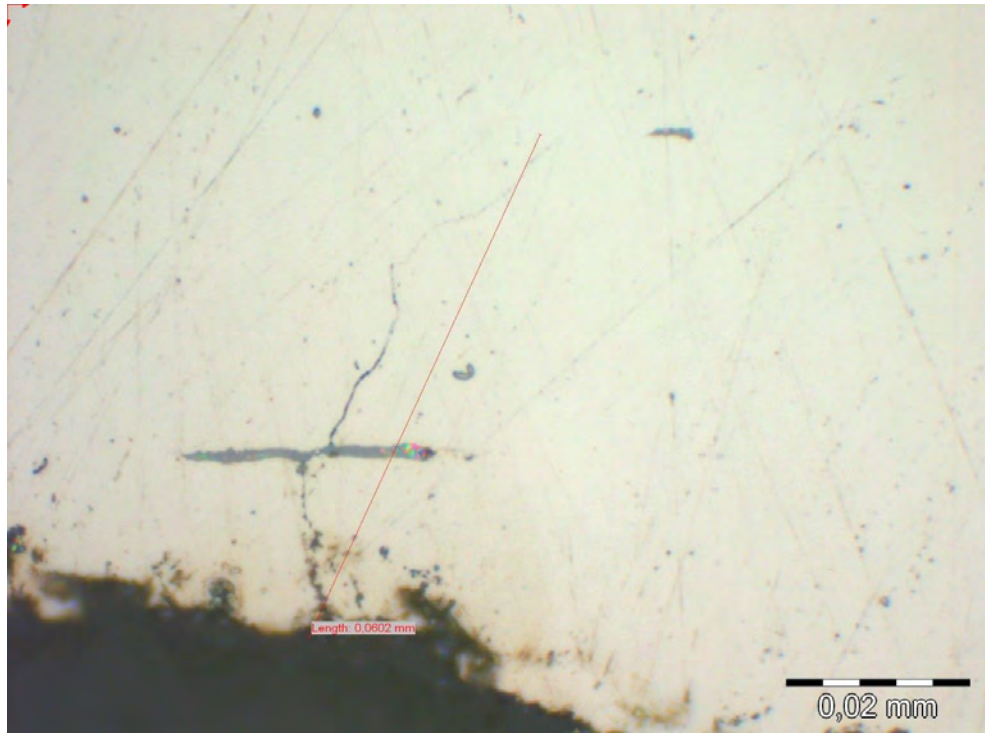
Figure C.101 Crack B at segment B, third ridge on barrel no. SFK 0120-A

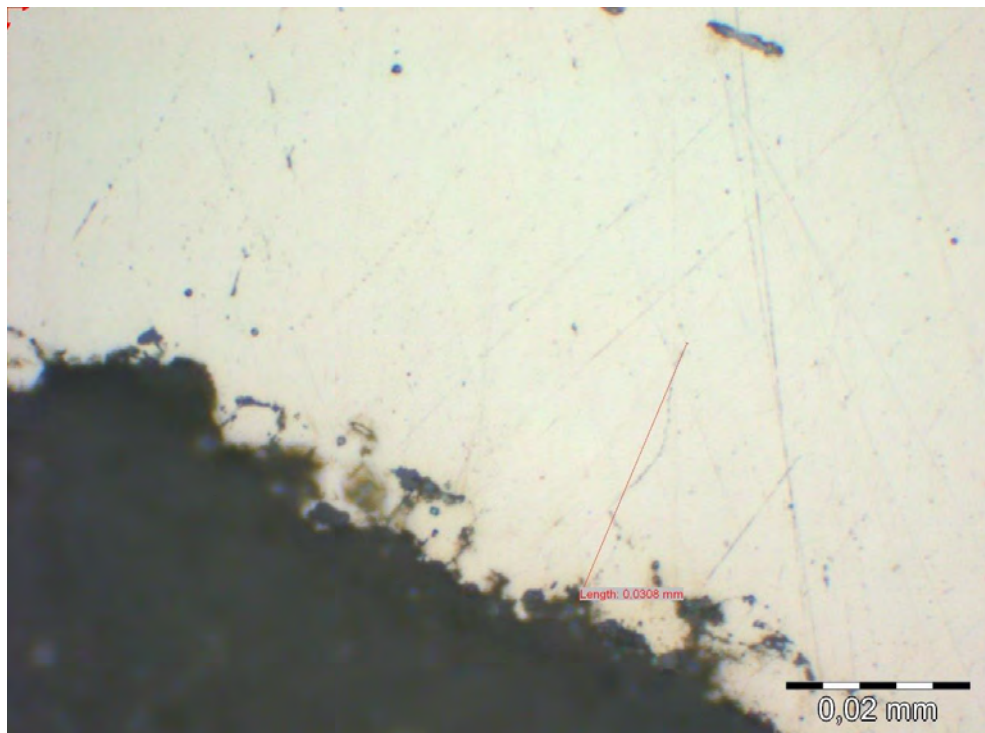
Figure C.102 Crack at segment B, fourth ridge on barrel no. SFK 0120-A

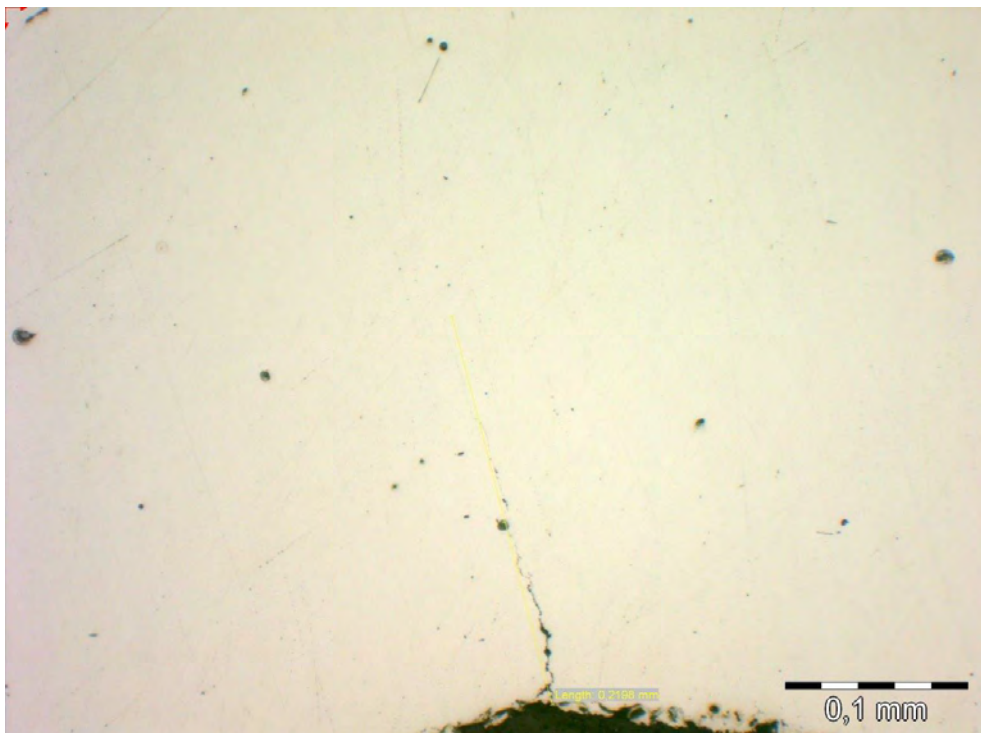
Figure C.103 Crack at segment C, first ridge on barrel no. SFK 0120-A

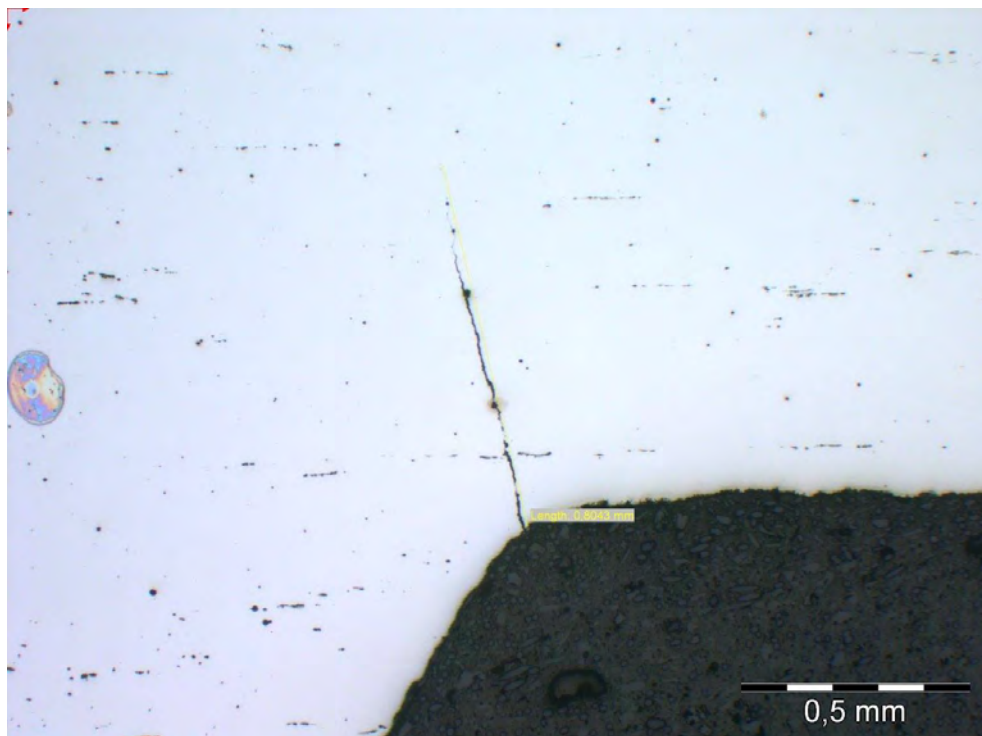
Figure C.104 Crack at segment A, first ridge on barrel no. SFK 0123-A

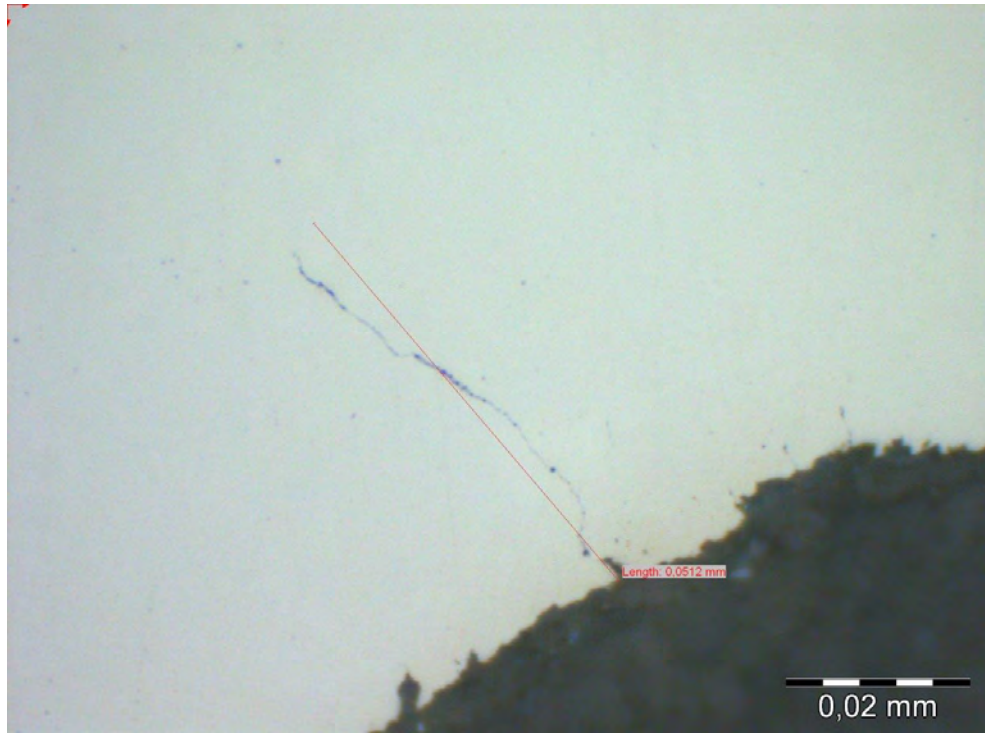
Figure C.107 Crack at segment A, fourth ridge on barrel no. SFK 0123-A

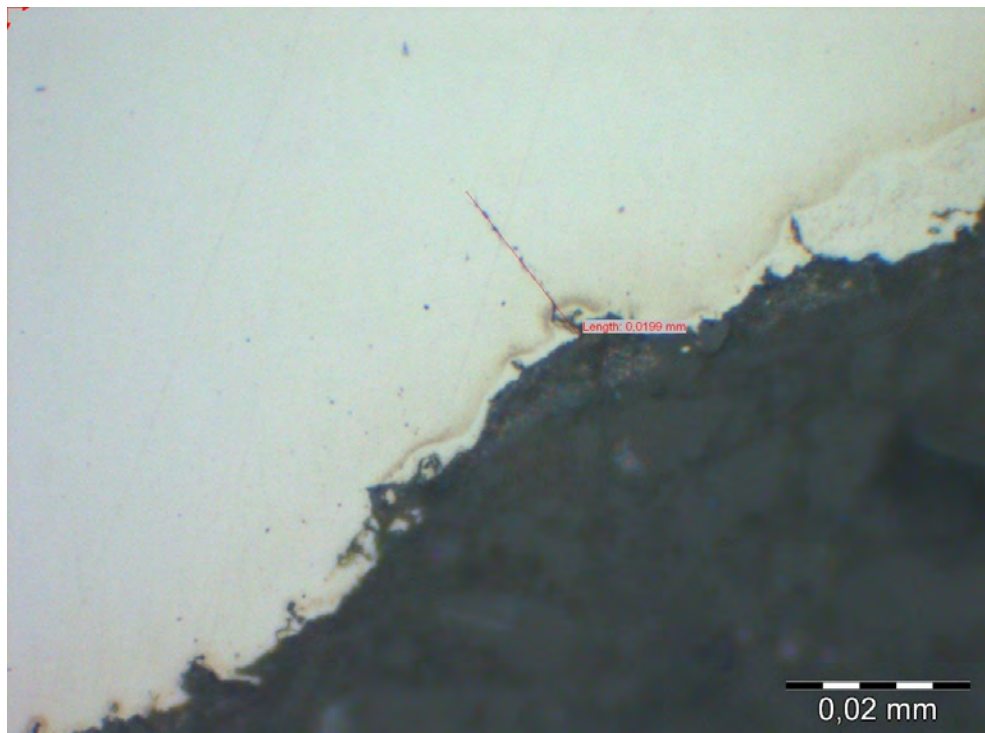
Figure C.108 Crack at segment A, fifth ridge on barrel no. SFK 0123-A

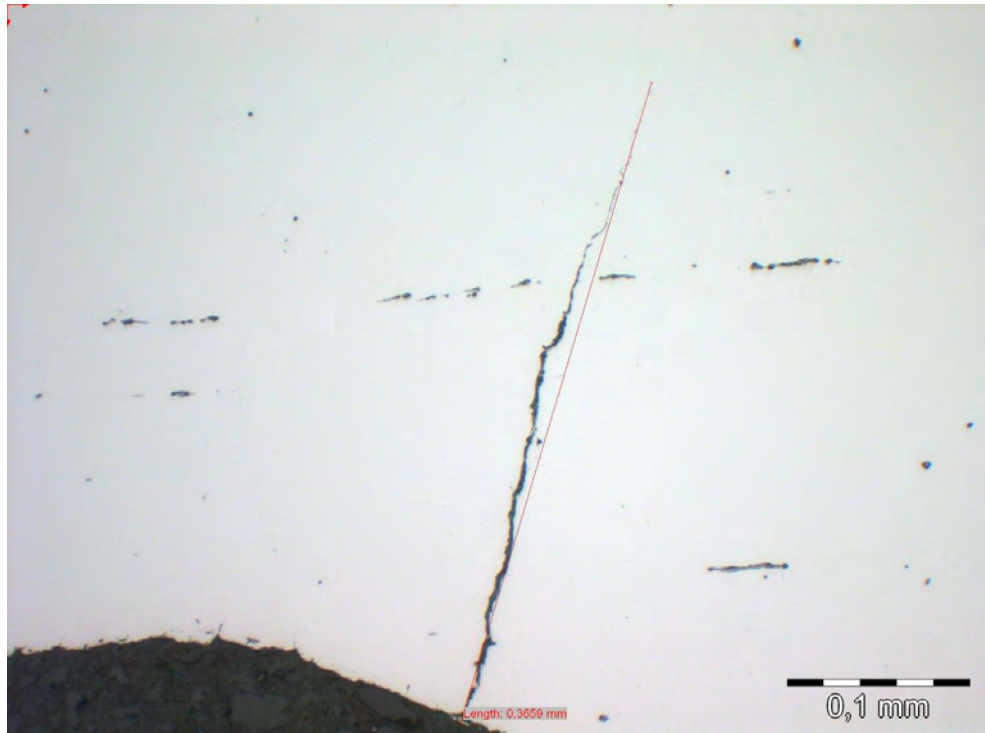
Figure C.111 Crack at segment B, third ridge on barrel no. SFK 0123-A

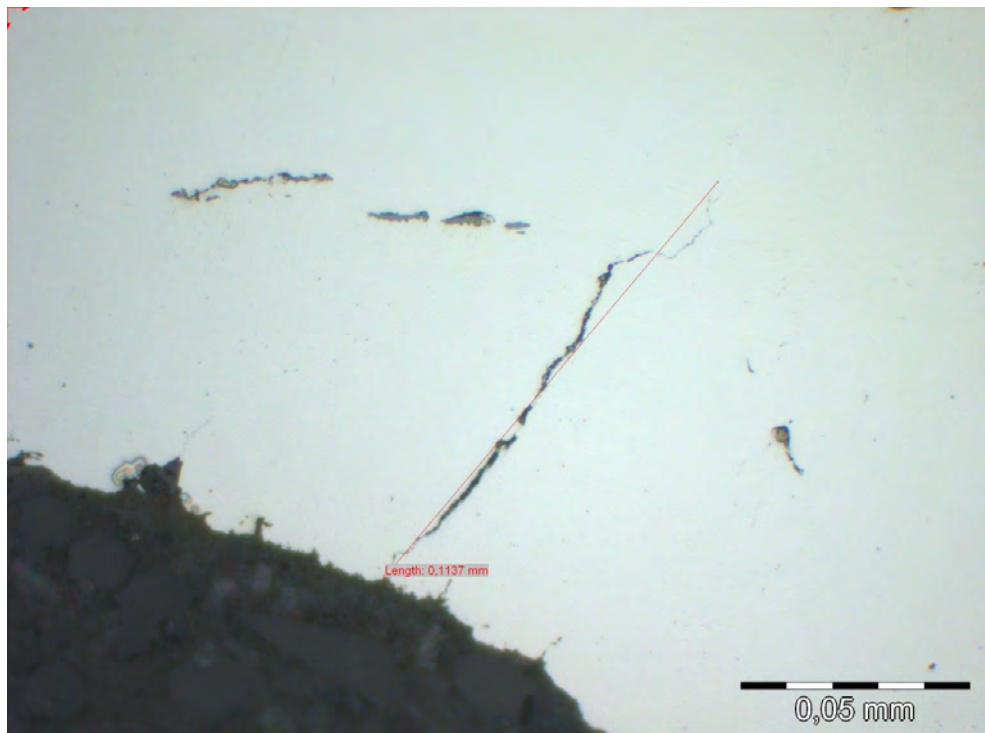
Figure C.112 Crack at segment B, fourth ridge on barrel no. SFK 0123-A
